CHATHAM TO LAKESHORE 230 KV TRANSMISSION LINE CLASS ENVIRONMENTAL ASSESSMENT

Draft Environmental Study Report

Report Number: 590-CLEA-19-2

2020 Natural Environment Existing Conditions

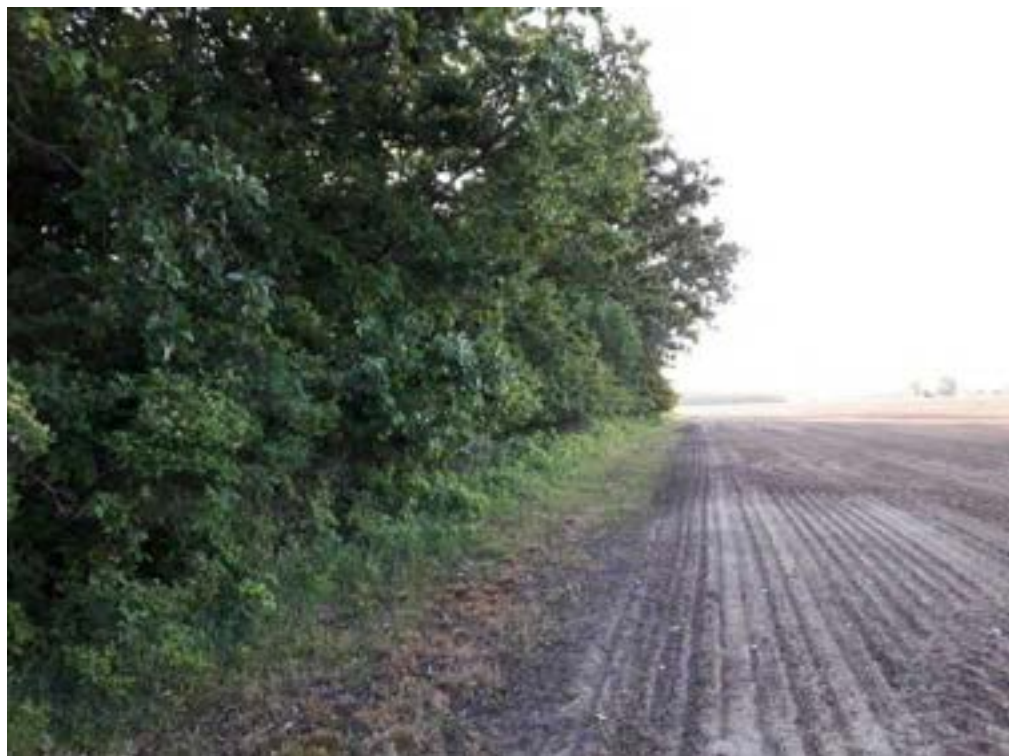
Note: Fresh-
Moist Shagbark
Hickory
Deciduous
Forest Type
(left) and Annual
Row Crops
(right).

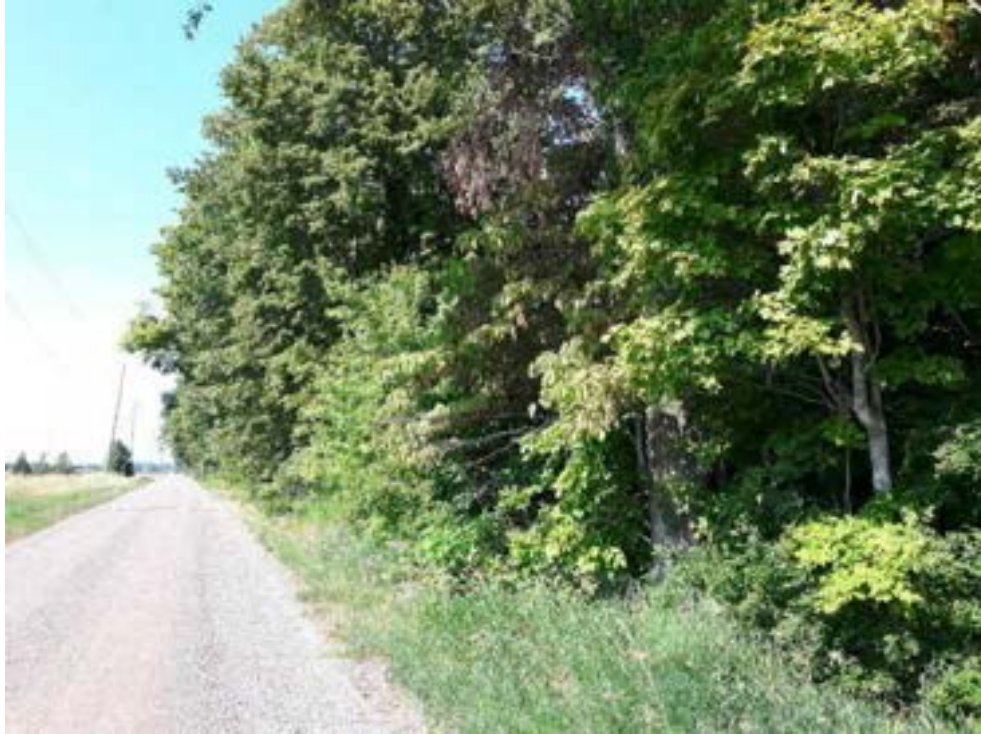
Photograph 50

Looking
southwest
towards Fresh-
Moist Sugar
Maple White
Elm Deciduous
Forest Type.

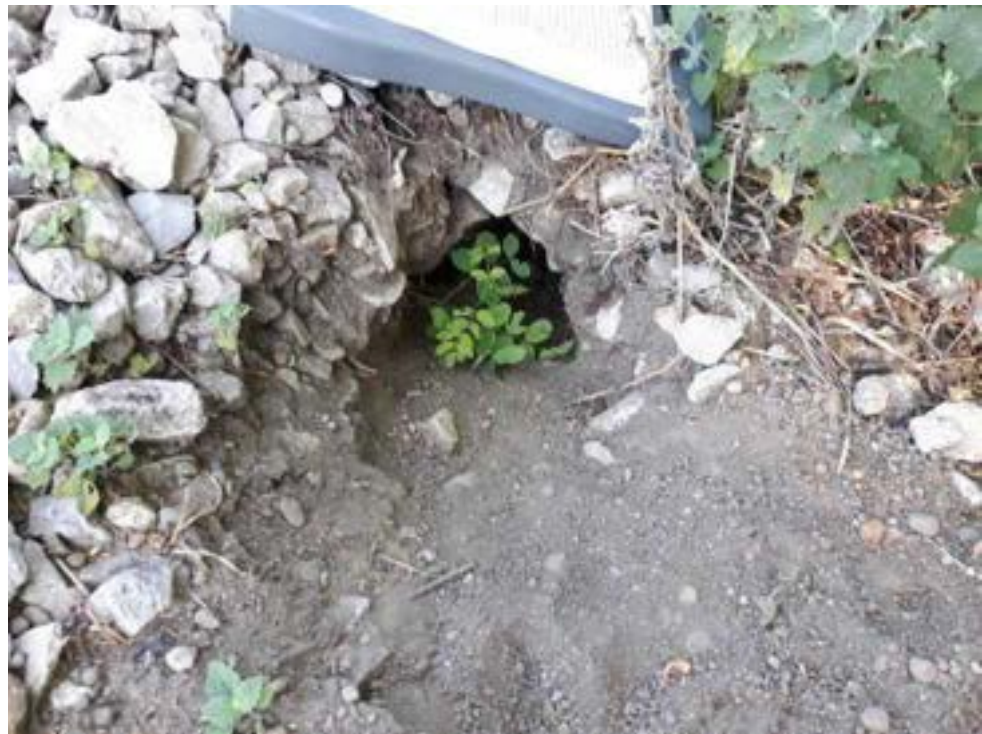
Burrow of
unknown animal
species
observed.

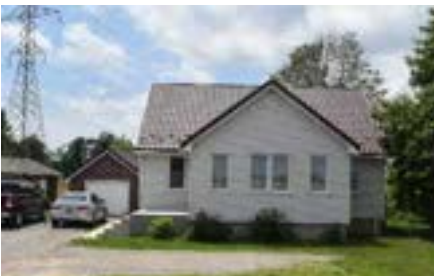
Single detached, one-storey, vinyl siding clad house. Roof appears to have been replaced with faux terracotta shingles. Not visible on early 20th century topographical mapping.	The property does not contain CHVI as it exhibits common architectural styles and materials, demonstrates an average level of construction expertise, and has no historical associations.
21892 Communication Road, Chatham

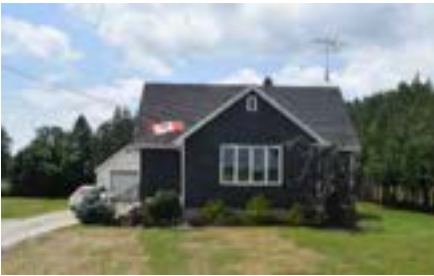
Single detached, one-storey, vinyl siding clad house. Not visible on early 20th century topographical mapping.	The property does not contain CHVI as it exhibits common architectural styles and materials, demonstrates an average level of construction expertise, and has no historical associations.

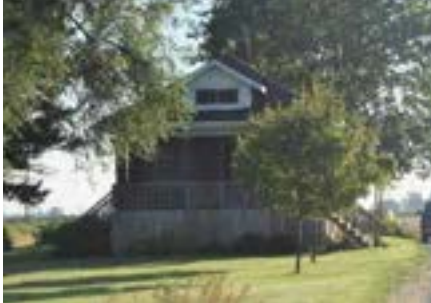
Single detached, storey-and-a-half, red brick house with wood panelling along foundation for open porch. Not visible on early 20th century topographical mapping.	The property does not contain CHVI as it exhibits common architectural styles and materials, demonstrates an average level of construction expertise, and has no historical associations.

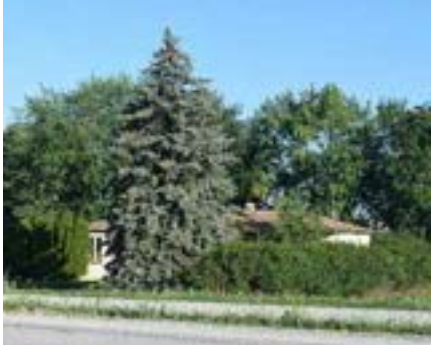
Single detached, one-storey, plaster/ stucco siding house. Earlier wooden house visible on property by early 20th century topographical mapping.	The property does not contain CHVI as it exhibits common architectural styles and materials, demonstrates an average level of construction expertise, and has no historical associations.
6086 3 Line Chatham
