**APPENDICES**  
**CHATHAM TO LAKESHORE 230 KV TRANSMISSION LINE**  
**CLASS ENVIRONMENTAL ASSESSMENT**  
**Draft Environmental Study Report**

Report Number: 590-CLEA-19-2

# 2020 Natural Environment Existing Conditions

Chatham X Lakeshore 230 kV Transmission Line Project Class EA

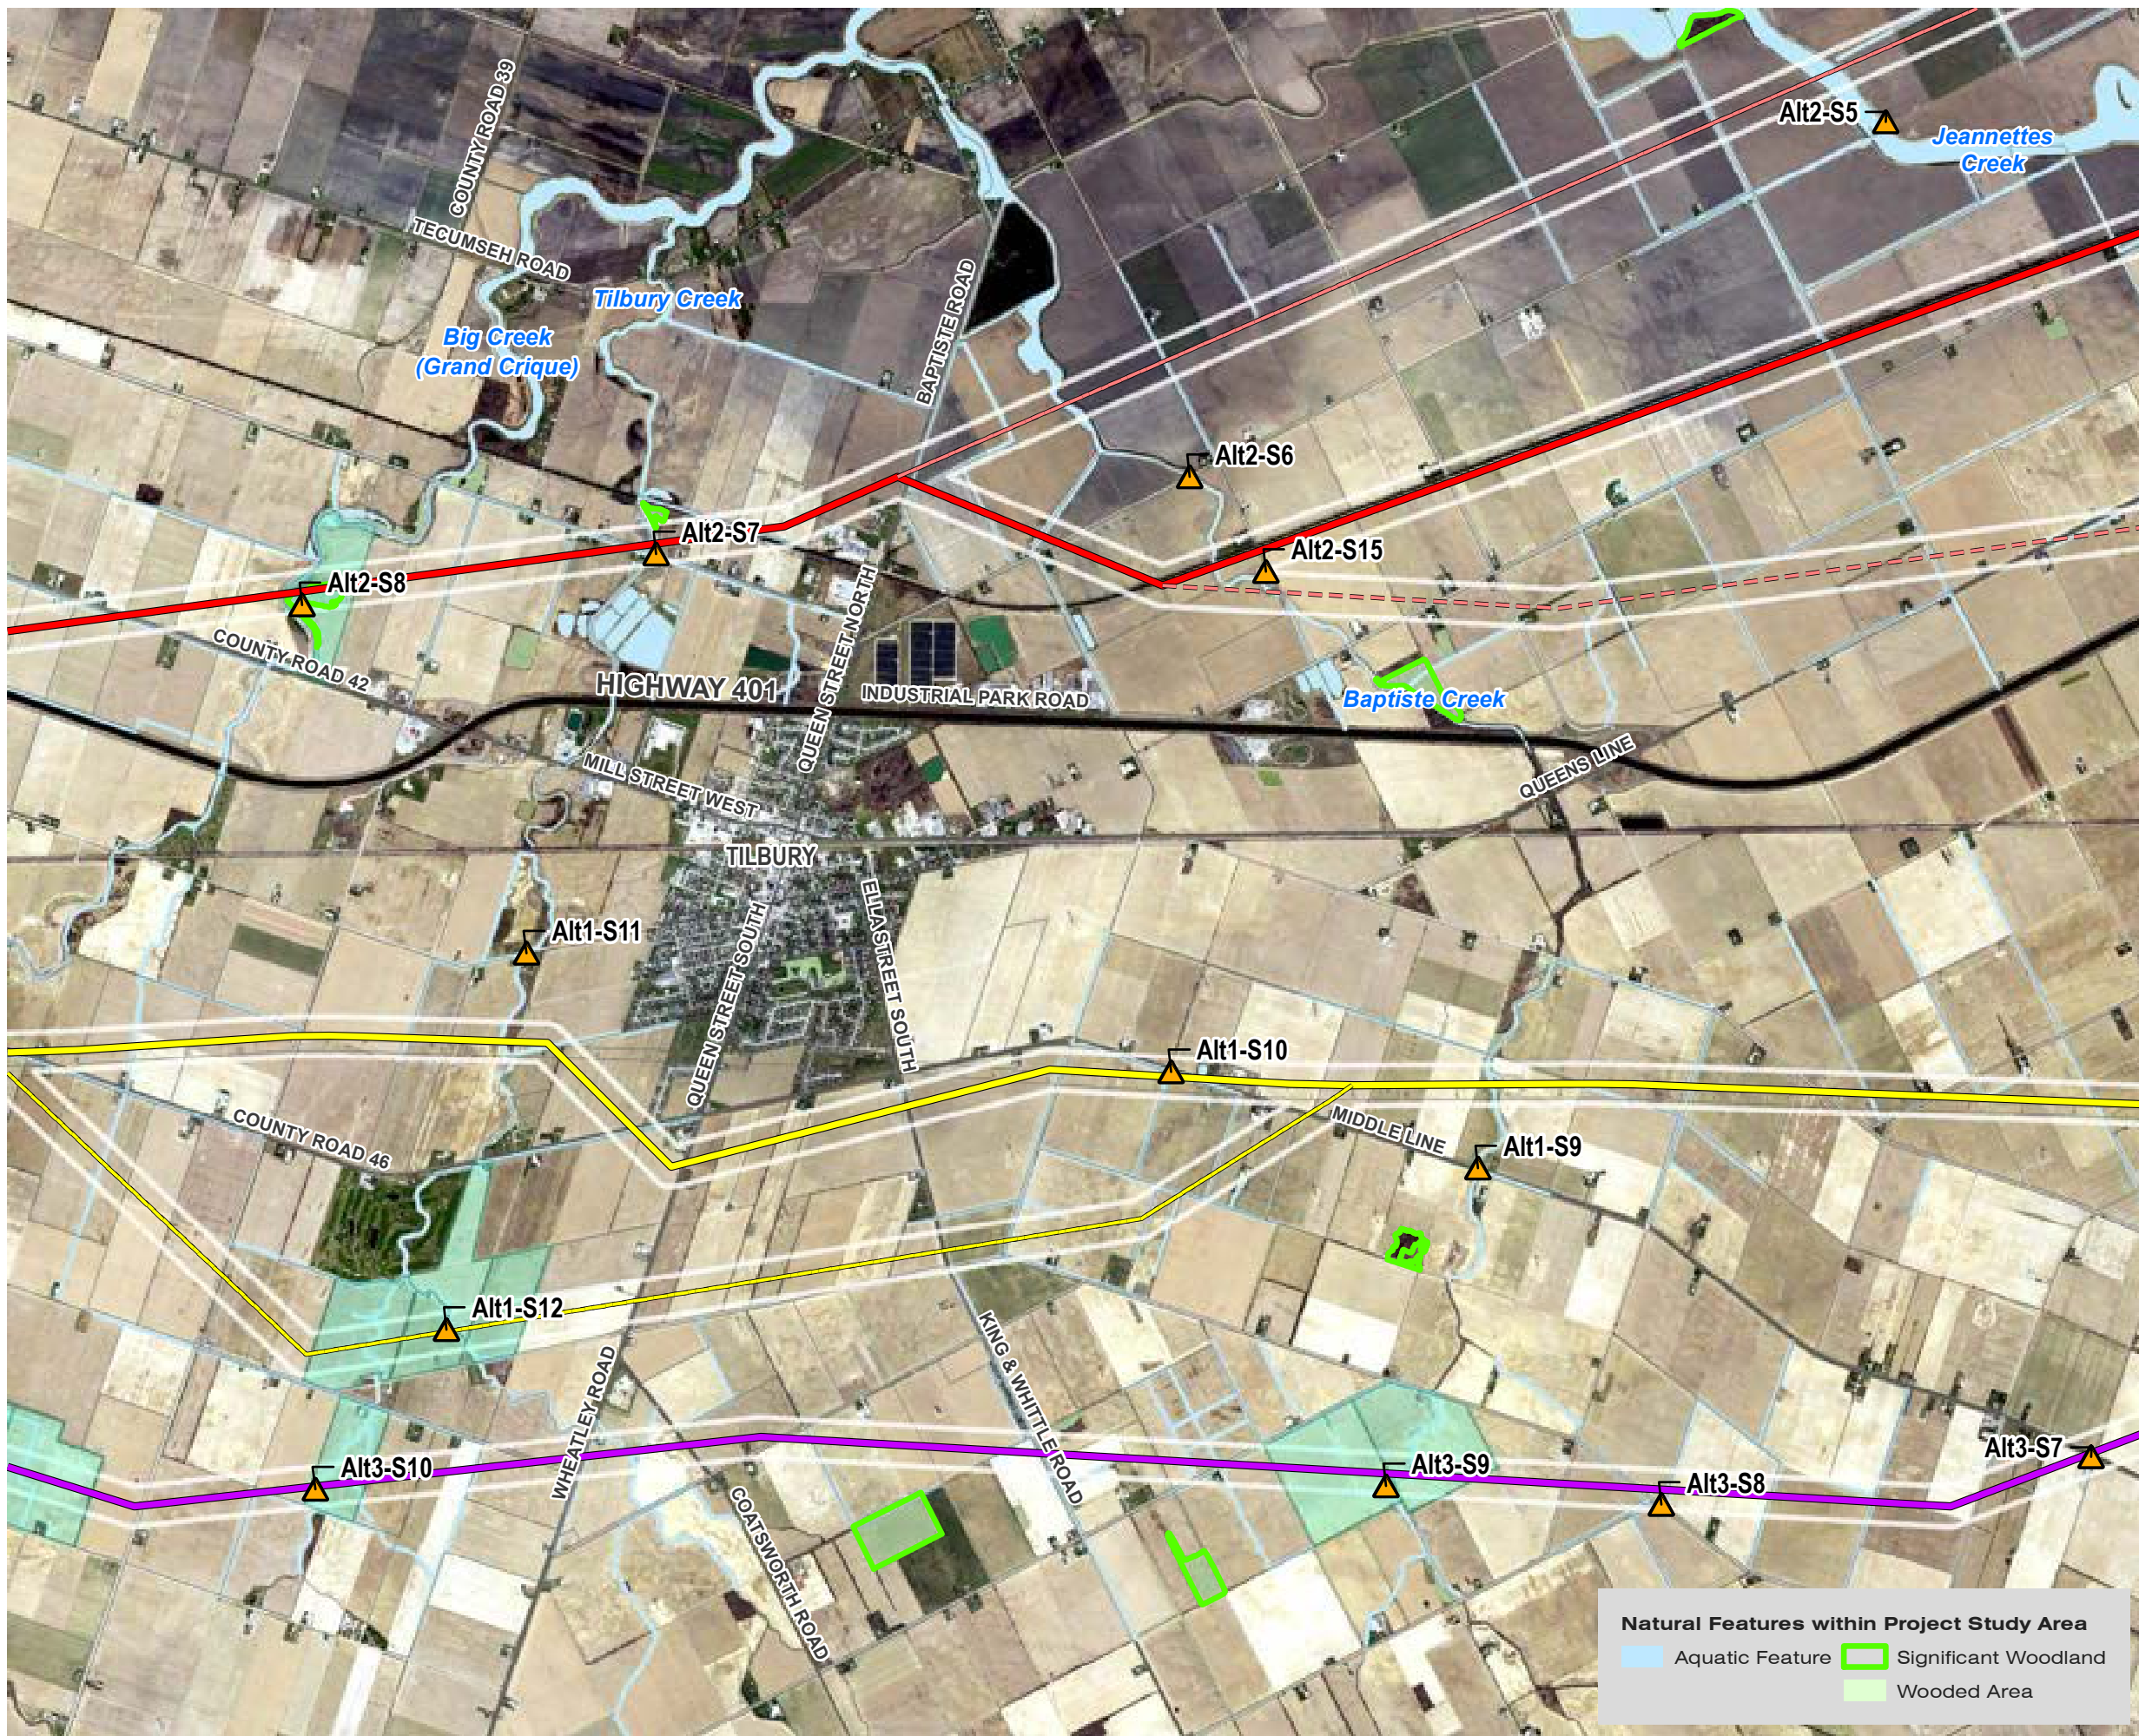
**PROPOSED SURVEY LOCATIONS  
FIGURE - 3C**

- Proposed Survey Locations
  - Alternative 1
  - Variation
  - Alternative 2
  - Variation
  - Alternative 3
  - Project Study Area (120m)
  - Parcel with Confirmed Access
  - Parcel
- Base Data**
- Highway
  - Road
  - Railway

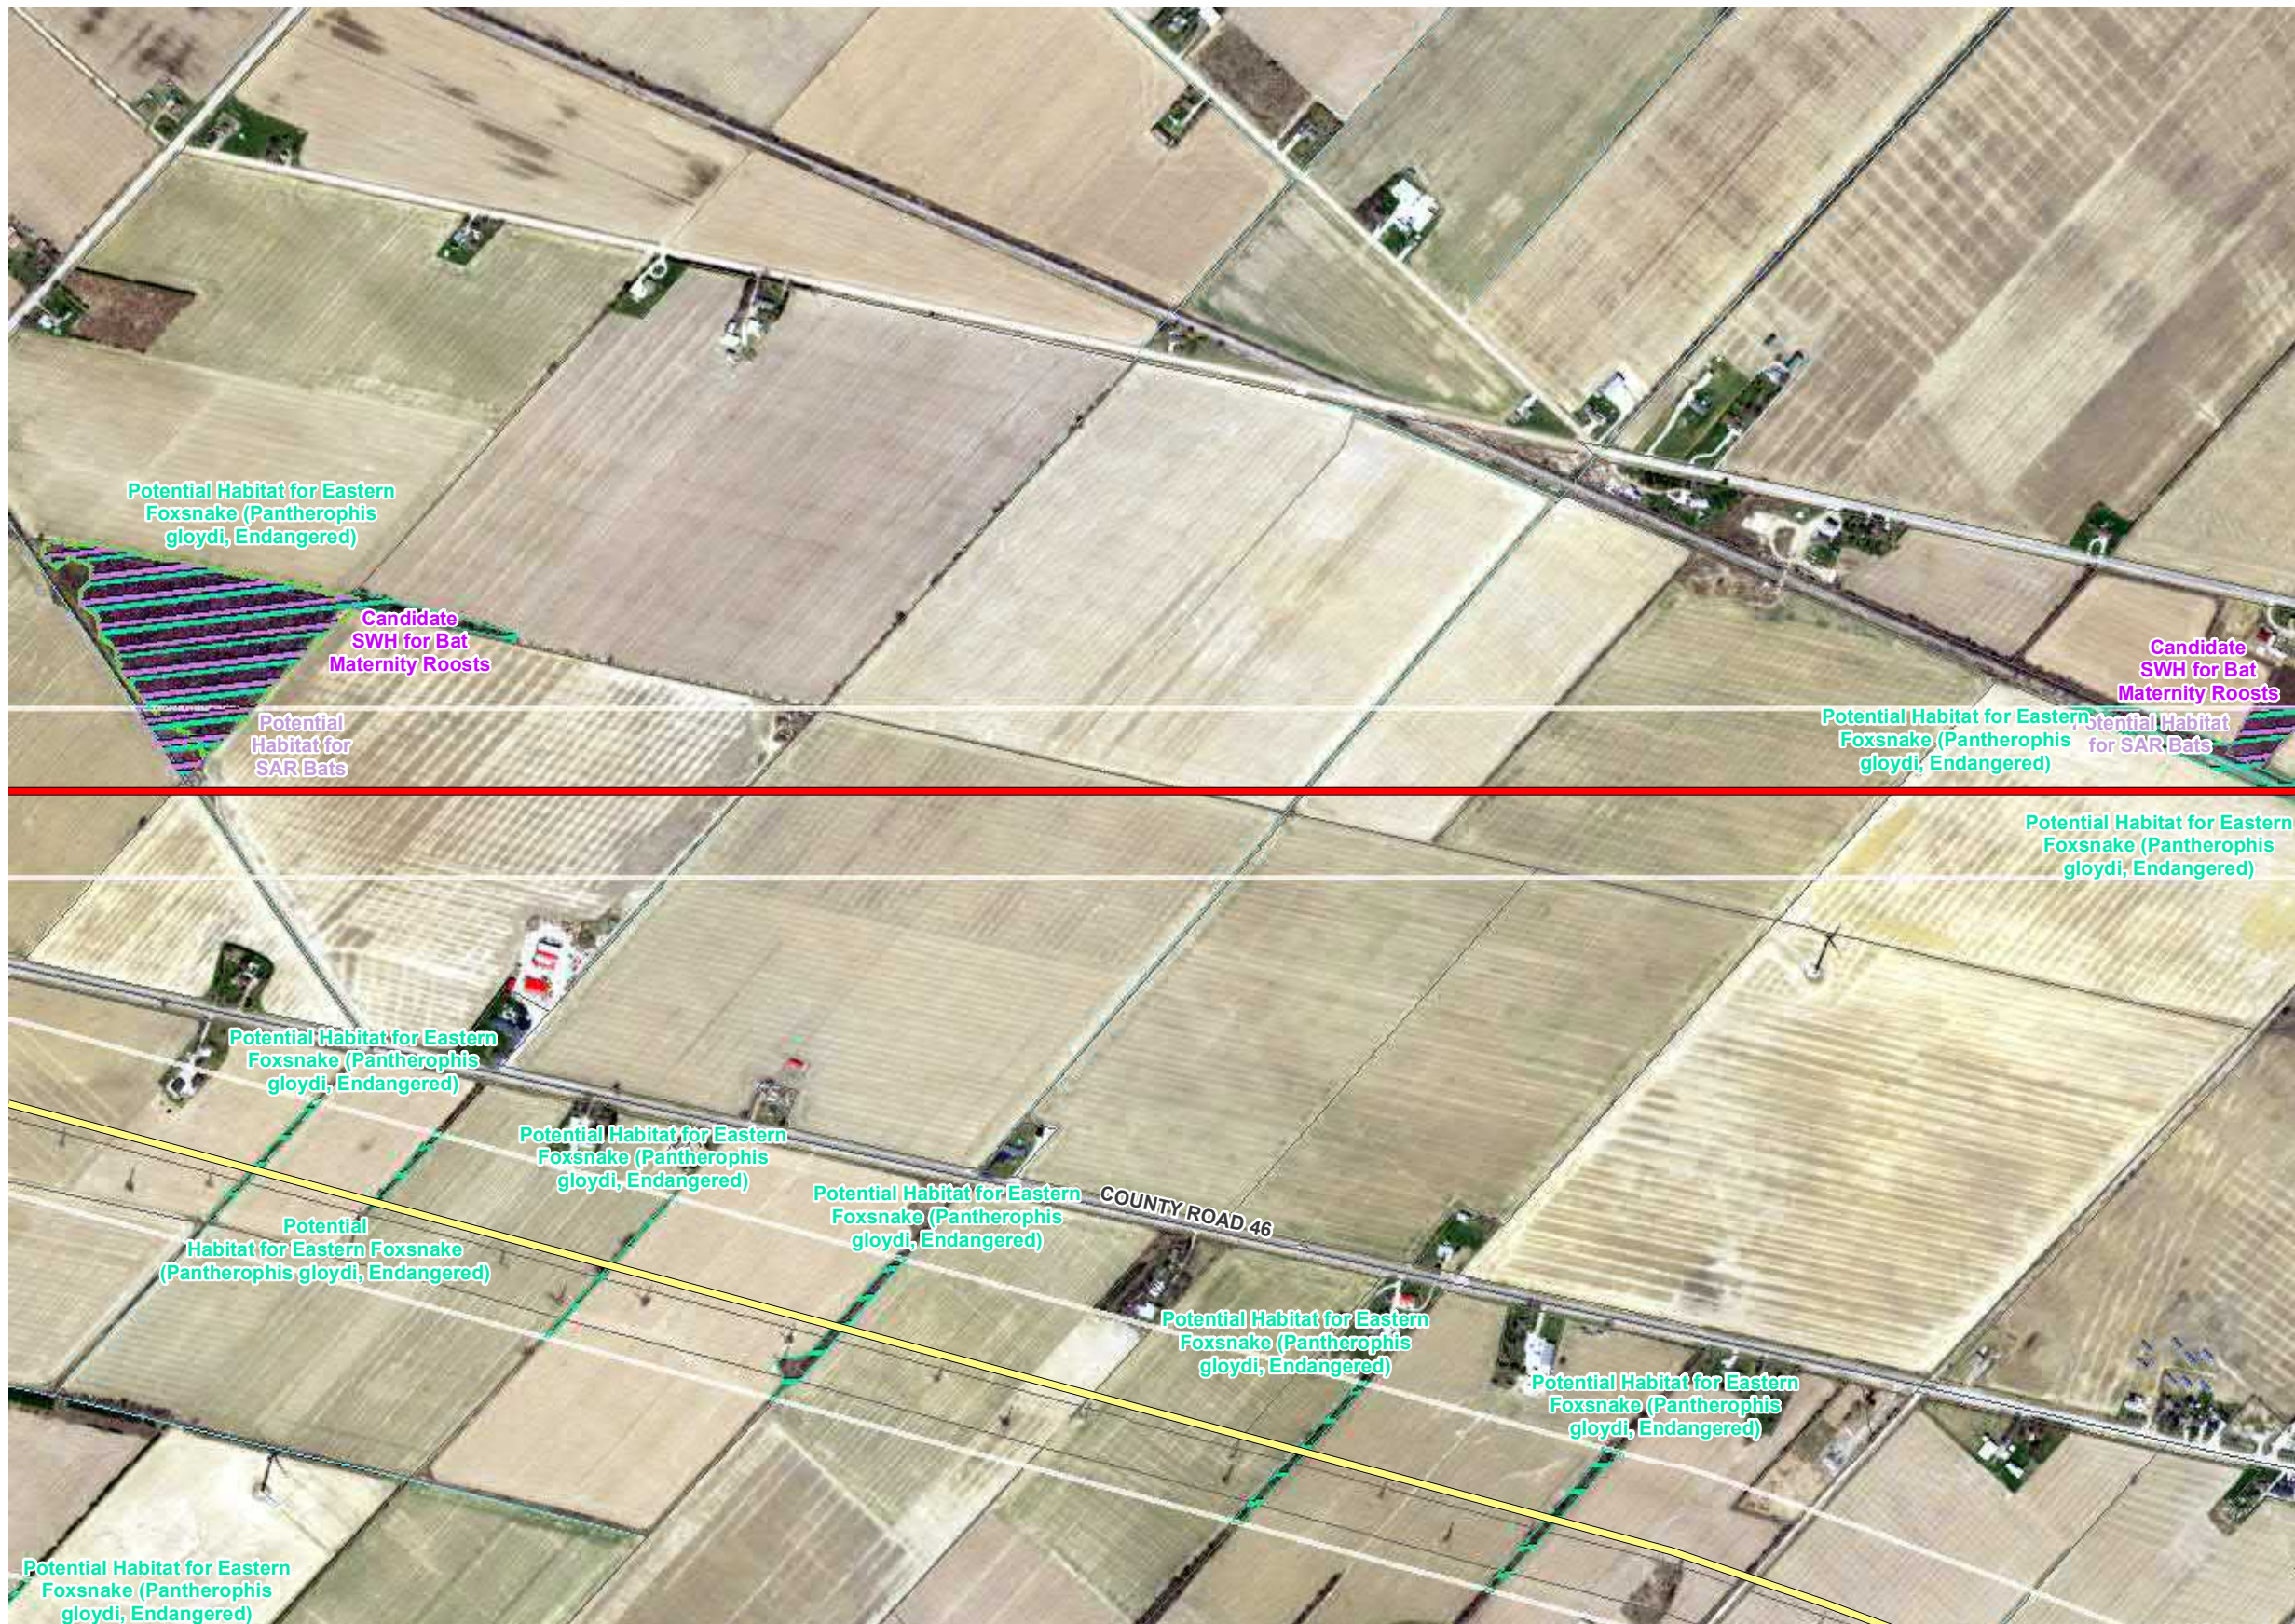
**NATURAL HERITAGE FEATURES  
FIGURE - 5B-18**

- Alternative 1
  - Variation
  - Alternative 2
  - Variation
  - Alternative 3
  - Project Study Area (120m)
  - Parcel
- Base Data**
- Highway
  - Road
  - Watercourse

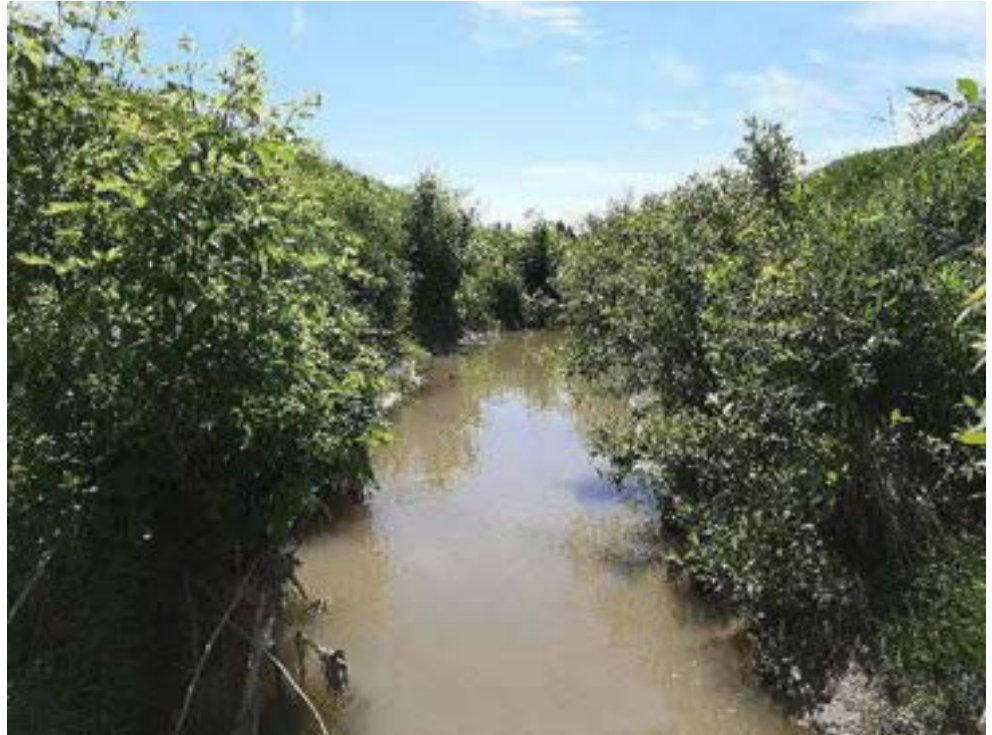
Photograph 2

Locke Drain,  
facing upstream  
(southeast) west  
of Charing Cross  
Road. Top  
predator fish  
species  
(Northern Pike  
or Longnose  
Gar) observed.

The most common substrate observed within the drainage features and watercourses consisted of clay with gravel and detritus; minor sand, boulder and cobble substrate were also observed. The dominant instream habitat consisted of emergent aquatic vegetation with woody debris and organic debris. Additional instream habitat features were comprised of boulders/cobble and undercut banks. Numerous young-of-the-year (YOY) fish were observed within Waddick Drain at survey station 4 and several small fish were observed in Kersey Drain at survey station 7. Numerous unidentified large fish were observed underneath the bridge in Deary Drain at survey station 8 and an adult top predator species (Northern Pike (*Esox lucius*) or Longnose Gar (*Lepisosteus osseus*) was observed in Locke Drain at survey station 2 (*Appendix C*).

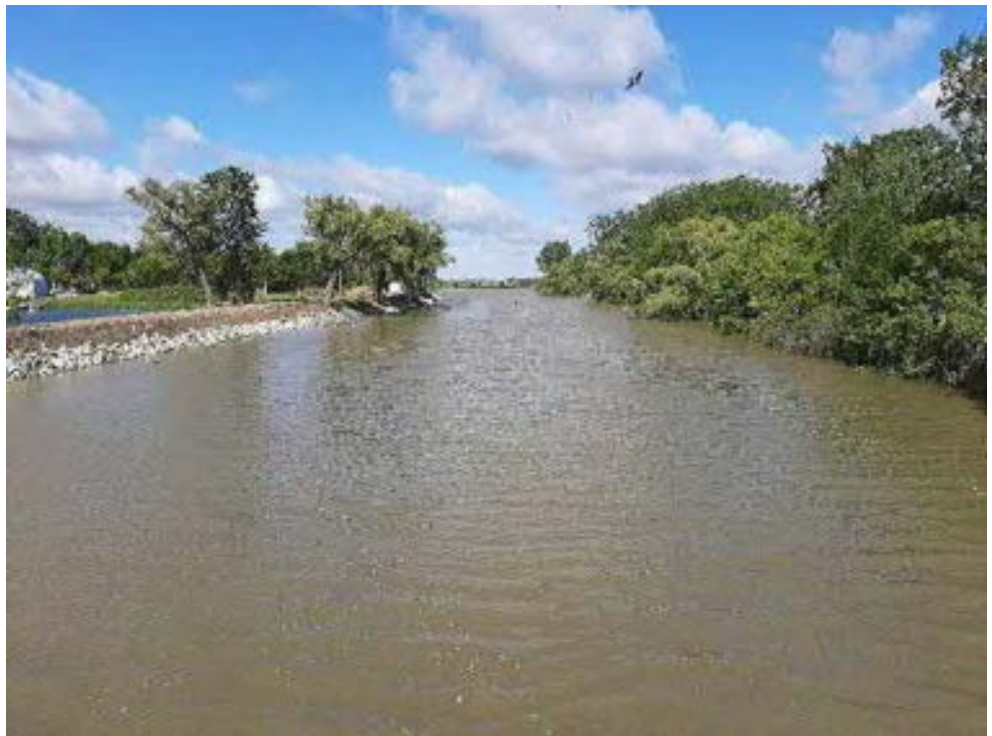
Route  
Alternative 1  
(Alt1-S3)

Duke Drain  
(Jeannettes  
Creek), facing  
downstream  
(northwest) at  
the 8<sup>th</sup> Line  
crossing.

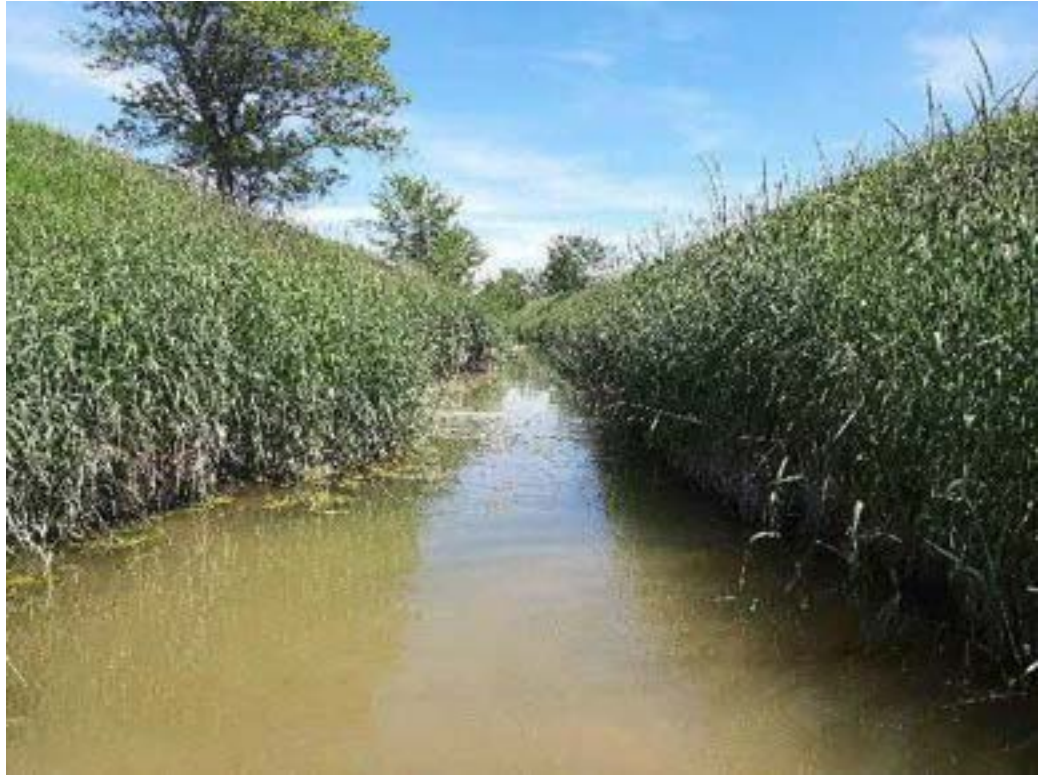
Route  
Alternative 1  
(Alt1-S4)

Waddick Drain,  
facing upstream  
(southeast) at  
the 8<sup>th</sup> Line  
crossing

Alt1_S4	42.33574	-82.190352	Waddick Drain	Municipal Drain	Gravel <sup>1</sup> , Sand, Cobble	2.9	15	0.55	Macrophytes, Boulders/Cobble, Undercut Banks, Woody Debris	M	M, A	Open	E	Run-flat morphology, turbid conditions, pool underneath bridge, several YOY fish observed	Direct – fish observed	3
Alt1_S5	42.329295	-82.214831	O'Rourke Drain	Municipal Drain	Clay, Detritus	1.2	6	0.25	Macrophytes, Organic Debris	M	M	Open	C	Turbid conditions with no flow, abundant detritus and instream vegetation, no fish observed	Direct based on DFO classification	4
Alt1_S6	42.330526	-82.219741	Government Drain	Municipal Drain	Clay <sup>1</sup> , Detritus	6	10	1	Undercut Banks, Macrophytes, Woody Debris	M, C	S, A	Open	C	Steep banks, turbid conditions with no flow, too deep to wade	Direct based on DFO classification	5
Alt1_S7	42.313243	-82.238083	Kersey Drain	Municipal Drain	Gravel <sup>1</sup> , Detritus, Sand	1.6	10	0.1	Macrophytes, Woody Debris, Organic Debris	M	M	Open	E	Clear flow present, abundant algae, culvert pool present, numerous small fish observed	Direct – fish observed	6

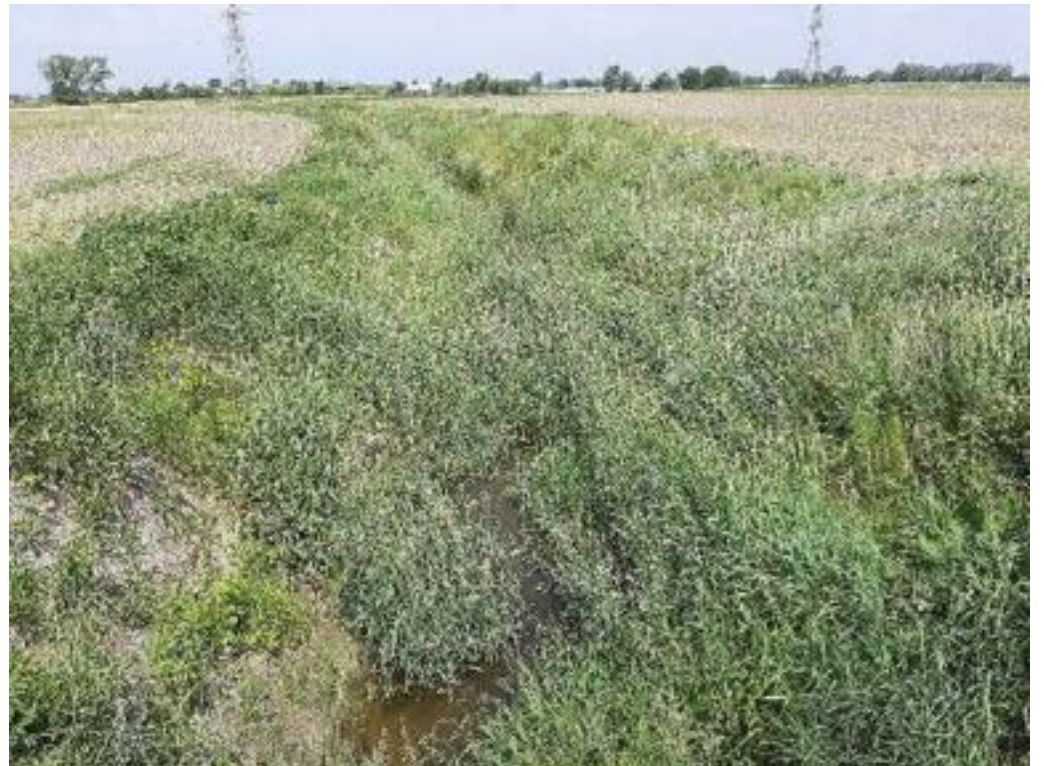
Route  
Alternative 1  
(Alt1-S5)

O'Rourke Drain,  
facing  
downstream  
(northwest), at  
the 7<sup>th</sup> Line  
West crossing.

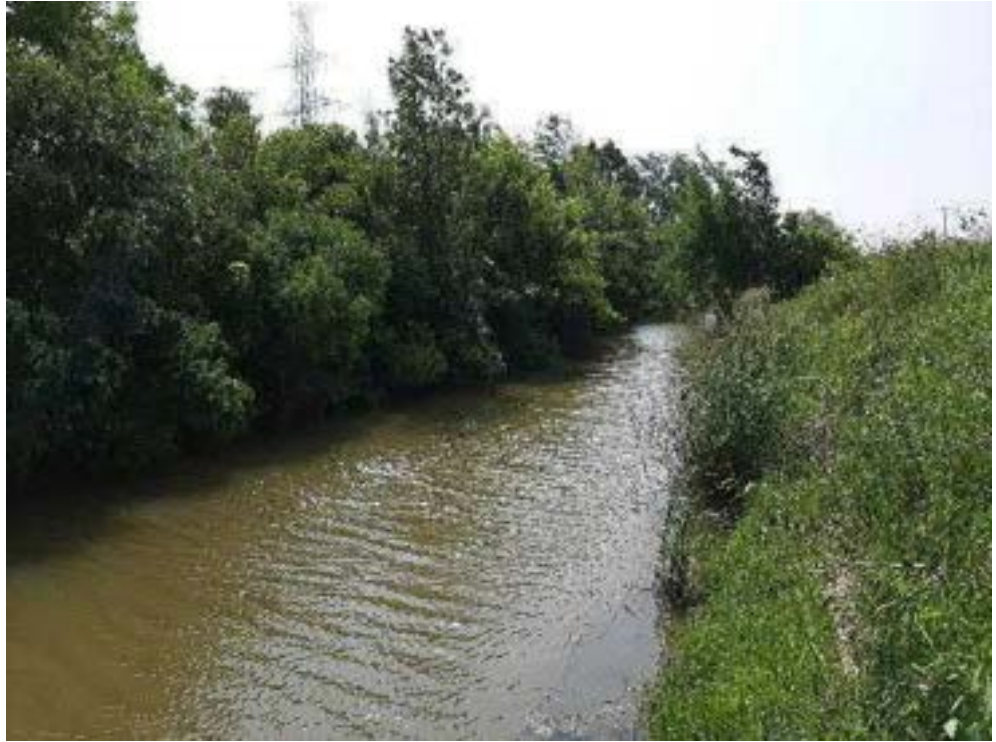
Route  
Alternative 1  
(Alt1-S6)

Government  
Drain, facing  
upstream  
(southeast),  
along Dillon  
Road.

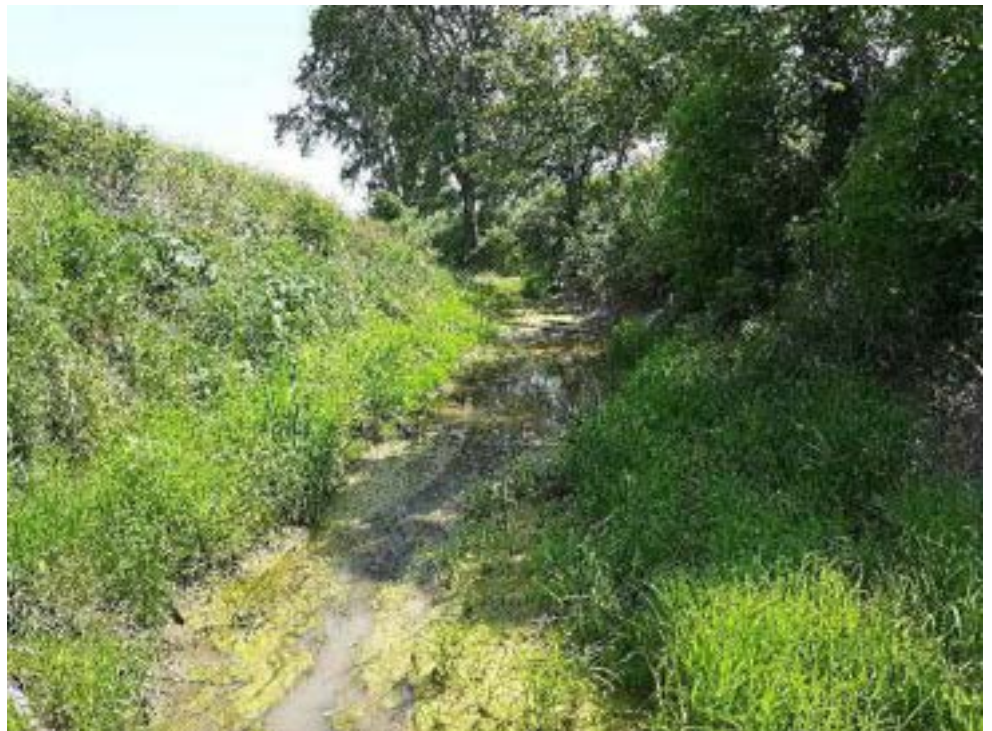
Route  
Alternative 1  
(Alt1-S7)

Kersey Drain,  
facing upstream  
(south) at the 7<sup>th</sup>  
Line West  
crossing.

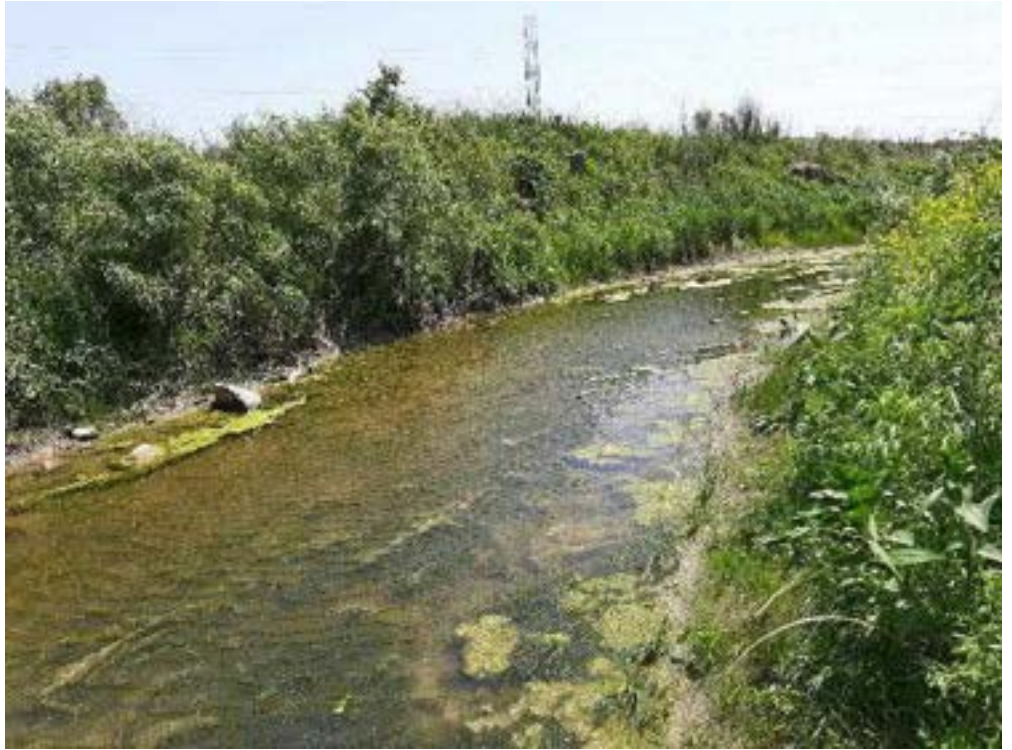
Route  
Alternative 1  
(Alt1-S8)

Deary Drain,  
facing upstream  
(south) at the  
Finn Line  
crossing.

Alt1_S8	42.280489	-82.299361	Deary Drain	Municipal Drain	Clay <sup>1</sup> , Cobble, Gravel, Detritus	4.7	12	0.25	Macrophytes, Woody Debris, Boulders, Cobble, Organic Debris	M, A	M	Open	NR	Turbid, little flow, numerous unidentified large fish observed underneath bridge	Direct – fish observed	7
Alt1_S9	42.25557	-82.376749	Baptiste Creek Drain (Baptiste Creek)	Municipal Drain	Clay <sup>1</sup> , Detritus, Boulder/Cobble	5	15	1	Woody Debris	C, A	S, A	Open	NR	Turbid, abundant riparian shade downstream, sever erosion upstream, no fish observed	Direct – based on habitat observed	8
Alt1_S10	42.256183	-82.400492	Powell Drain	Municipal Drain	Clay <sup>1</sup> , Gravel, Detritus	2.5	8	0.15	Macrophytes, Organic Debris, Boulders/Cobble	A	C, A	Open	NR	Channelized roadside drain with abundant emergent and floating aquatic and algae	Direct - based on conditions observed	9
Alt1_S11	42.253039	-82.448624	Tremblay Creek Drain (Tilbury Creek)	Municipal Drain	--	6	14	1+	Macrophytes, Woody Debris, Organic Debris	S, C	C, S	Open	E	Very turbid, wide, deep and not wadeable. Natural channel with abundant overhanging riparian vegetation	Direct based on DFO classification	10

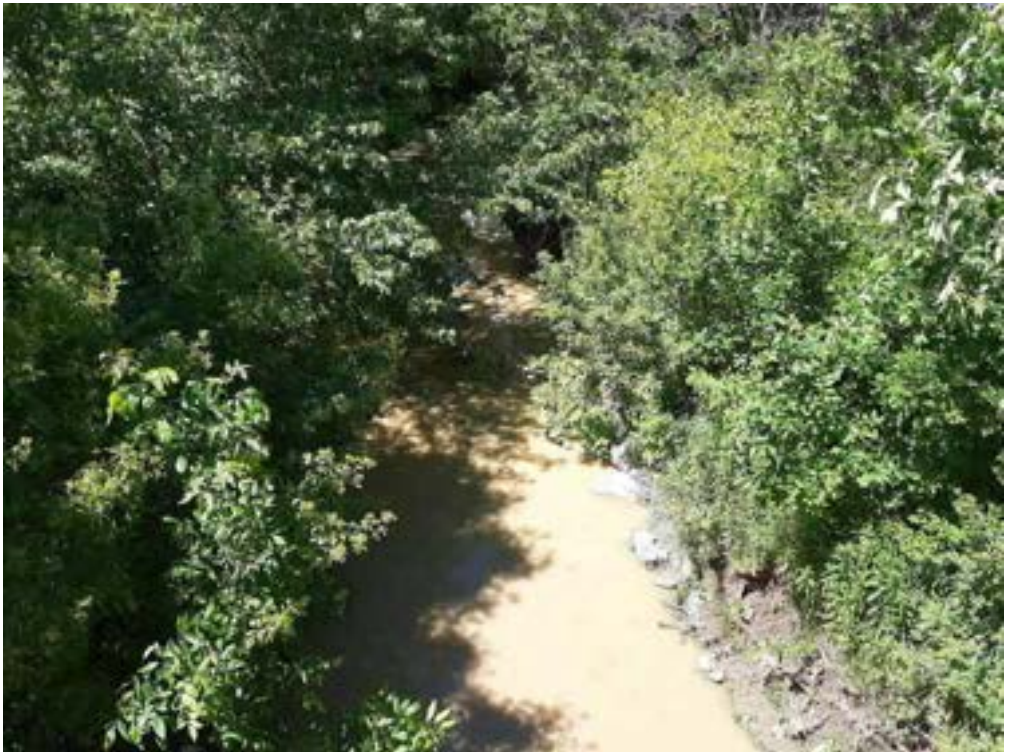
Route  
Alternative 1  
(Alt1-S9)

Baptiste Creek  
Drain (Baptiste  
Creek), facing  
downstream  
(north) from the  
Middle Line  
crossing.

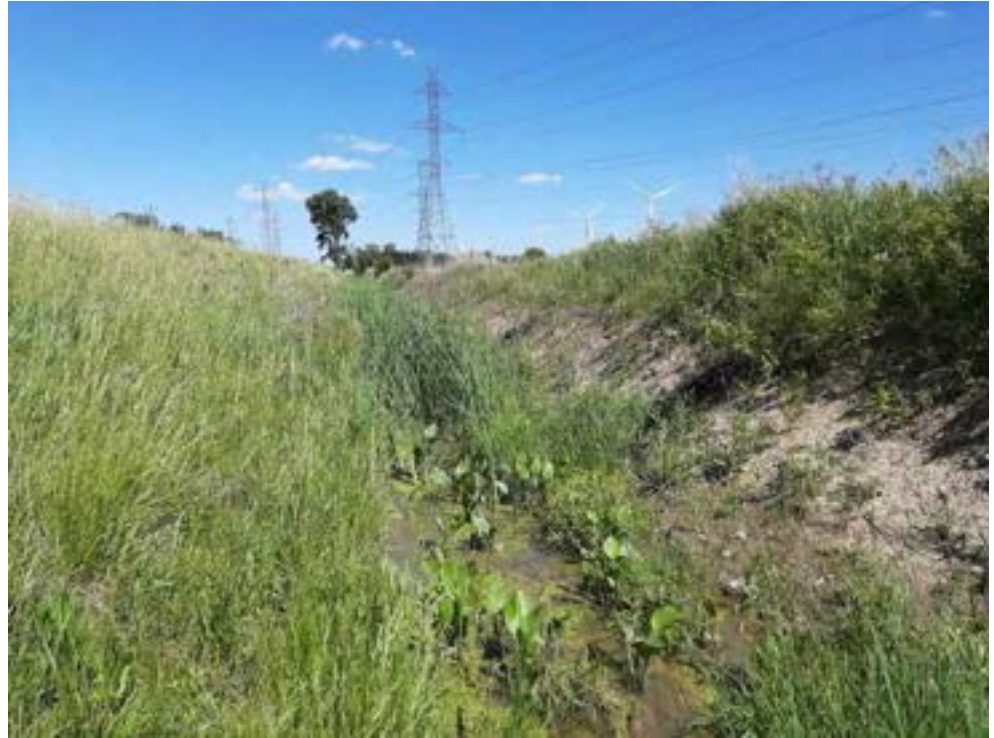
Route  
Alternative 1  
(Alt1-S10)

Powell Drain,  
facing  
downstream  
(east) along  
Middle Line.

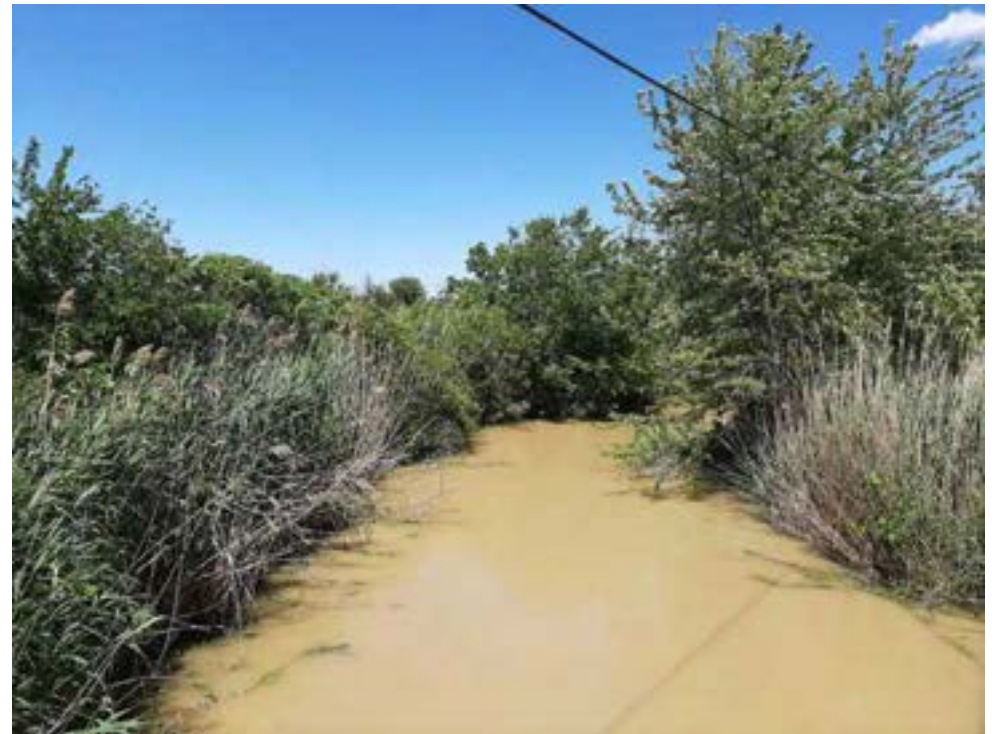
Route  
Alternative 1  
(Alt1-S11)

Tremblay Creek  
Drain (Tilbury  
Creek) facing  
downstream  
(north).

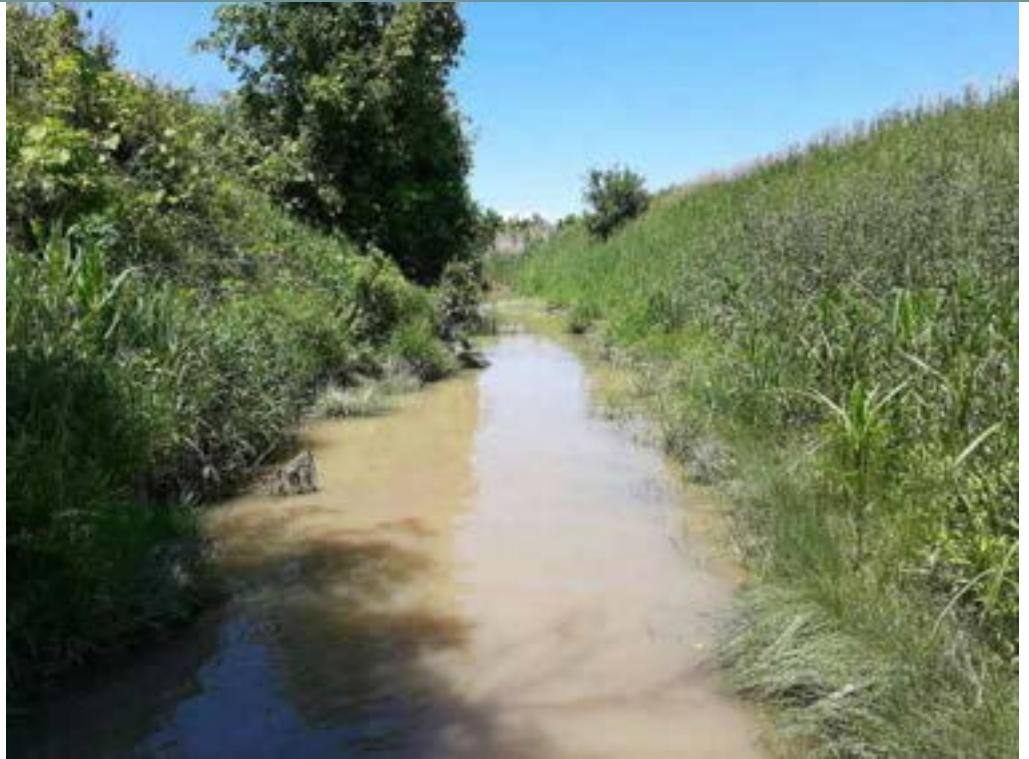
Route  
Alternative 1  
(Alt1-S12)

Tremblay Creek  
Drain (Tilbury  
Creek) facing  
downstream  
(northwest).

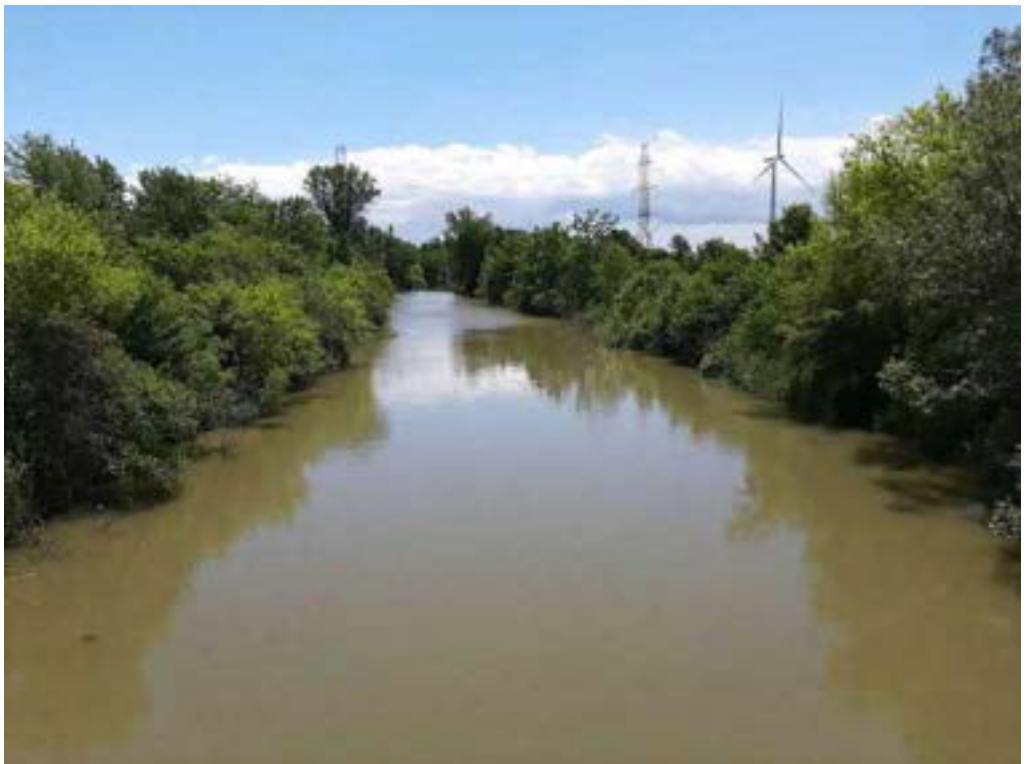
Route  
Alternative 1  
(Alt1-S13)

Big Creek Drain  
(Big Creek)  
facing upstream  
(south) at the  
County Road 46  
crossing.

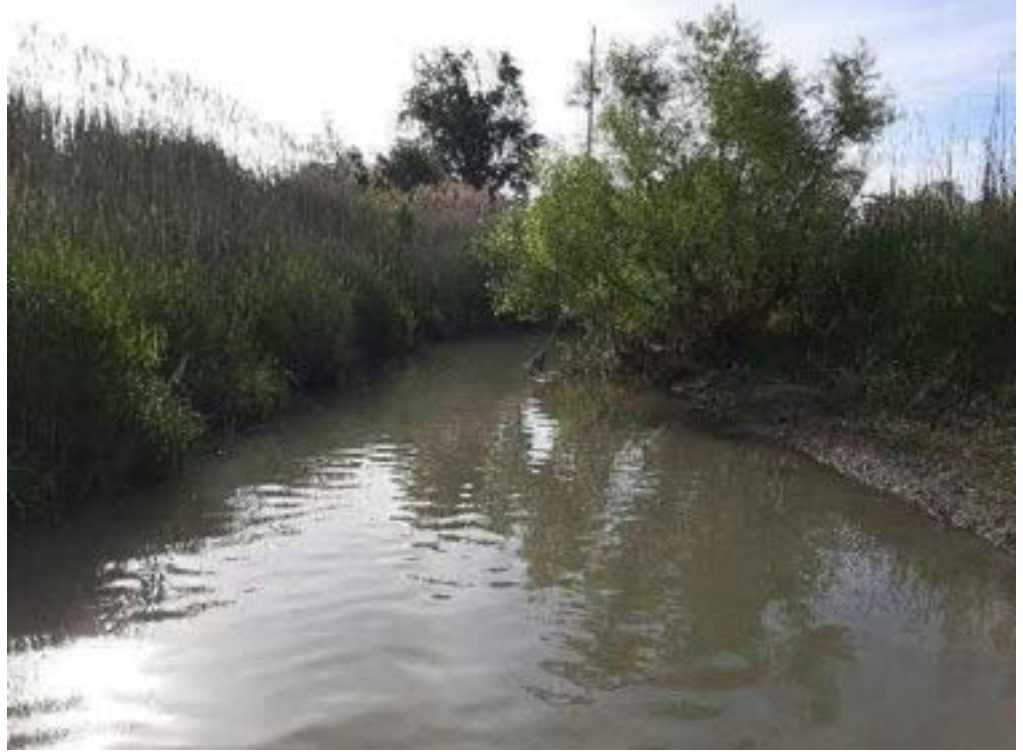
McGregor Creek  
Drain, facing  
upstream  
(southwest)  
along  
Communication  
Road.

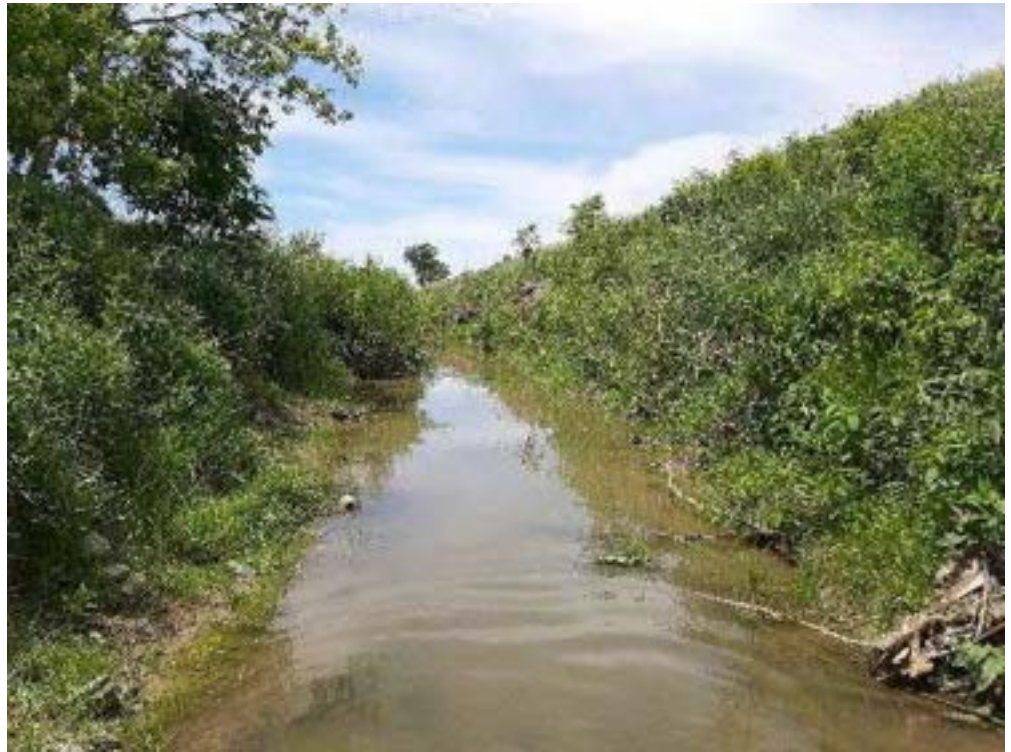
Photograph 14

Chinnick Drain  
(Indian Creek),  
facing  
downstream  
(northeast) at  
the Howard  
Road crossing.

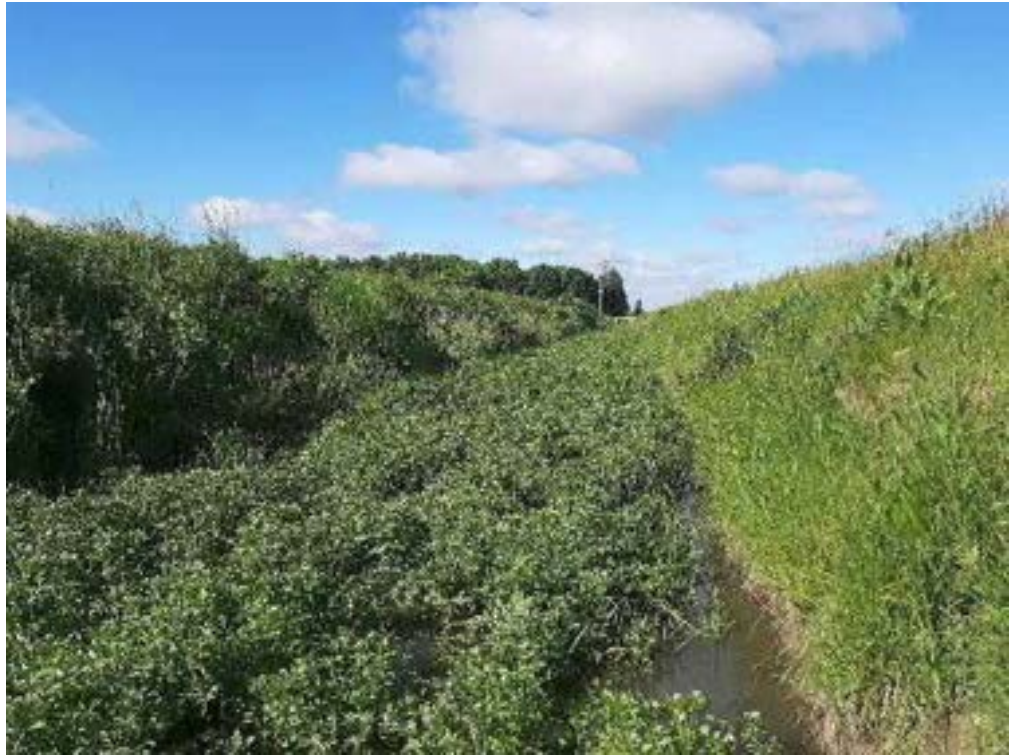
Bullis Creek  
Drain (Bullis  
Creek), facing  
downstream  
(southwest)  
along Queens  
Line.

Alt2_S3	42.364821	-82.23785	Bullis Creek Drain (Bullis Creek)	Municipal Drain	Clay <sup>1</sup> , Detritus	5	10	0.32	Macrophytes	C, M	M, A	Open	C	Soft sediment, unsafe to wade, no flow, abundant instream vegetation, no fish observed	Direct based on DFO classification	15
Alt2_S5	42.316717	-82.367989	Ferguson Drain (Jeanettes Creek)	--	Clay, Detritus, Boulders/Cobble	110	120	2+	Macrophytes, Woody Debris, Boulders/Cobble, Organic Debris	C, A	C, A	Open	E	Very wide, deep, turbid, low gradient section with rip rap along banks, abundant Phragmites along shoreline	Direct based on DFO classification	16
Alt2_S6	42.287949	-82.410871	Baptiste Creek Drain (Baptiste Creek)	--	--	20	30	2+	Macrophytes, Woody Debris, Boulders/Cobble, Organic Debris	C	A, C	Open	NR	Very wide, deep, turbid, low gradient section with limited riparian shade and flood control berms along both banks	Direct based on conditions observed	17

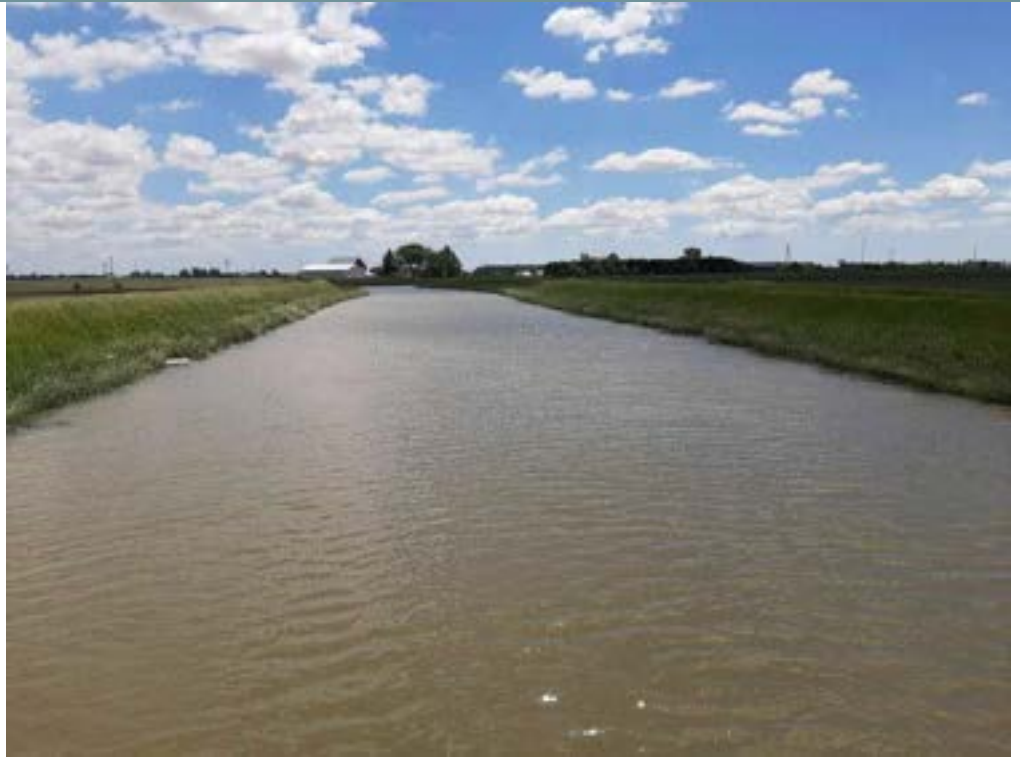
Baptiste Creek  
Drain (Baptiste  
Creek), facing  
upstream  
(southeast) at  
the Mint Line  
crossing.

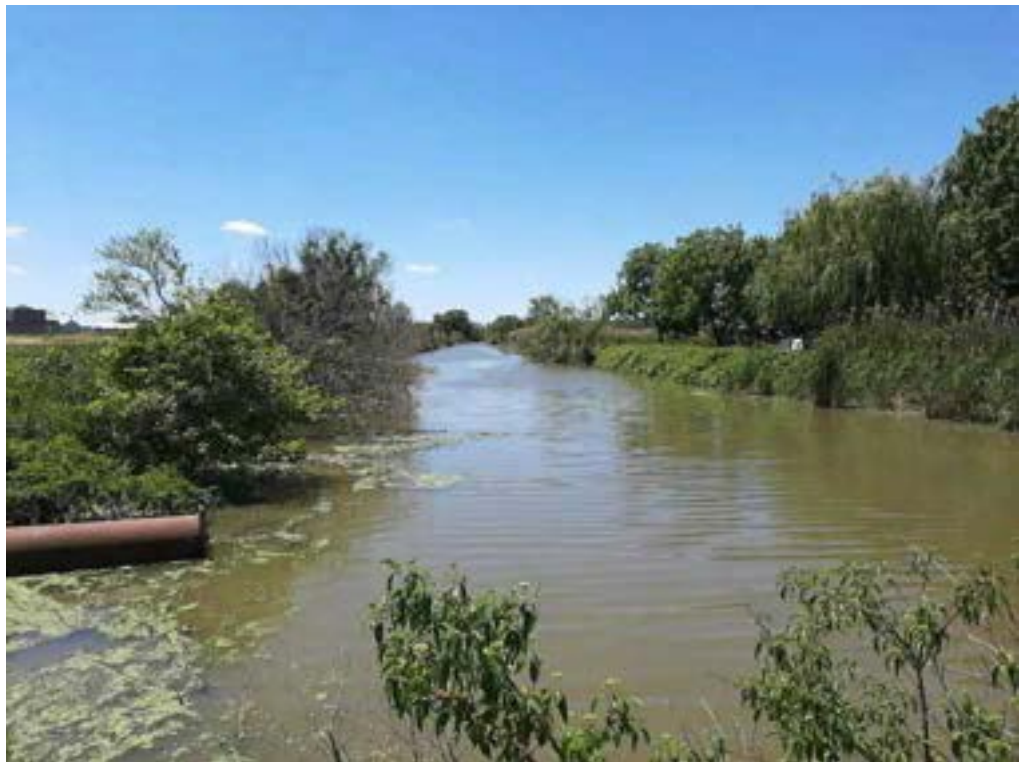
Photograph 18

Tremblay Creek  
Drain (Tilbury  
Creek), facing  
upstream  
(south) at the  
Concession  
Road 3 crossing.

Alt2_S7	42.276073	-82.447496	Tremblay Creek Drain (Tilbury Creek)	Municipal Drain	--	17	24	1+	Macrophytes, Woody Debris, Boulders/Cobble, Organic Debris	S, A	C, S	Open	NR	Wide, deep, very turbid, low gradient section, emergent and floating aquatic vegetation observed	Direct based on conditions observed	18
Alt2_S8	42.26767	-82.471605	Big Creek Drain (Big Creek)	Municipal Drain	--	30	40	2+	Macrophytes, Woody Debris, Organic Debris	F, A	S, A	Open	C	Wide, deep, very turbid, low gradient section, not wadeable, very steep densely vegetated bank with difficult access to watercourse	Direct based on DFO classification	19
Alt2_S9	42.256484	-82.506868	Unnamed Feature	--	Clay <sup>1</sup>	--	--	--	--	C	A	Open	--	Dry, ill-defined swale along the Gracey Sideroad toe of slope	No	20
Alt2_S11	42.253453	-82.517464	Little Creek	Municipal Drain	Clay <sup>1</sup> , Gravel, Detritus	1.5	4	0.2	Macrophytes, Organic Debris	C	C	Open	E	Narrow, shallow channel, flowing clear, abundant Cattails and instream aquatic vegetation	Direct based on DFO classification	21
