**APPENDICES**  
**CHATHAM TO LAKESHORE 230 KV TRANSMISSION LINE**  
**CLASS ENVIRONMENTAL ASSESSMENT**  
**Draft Environmental Study Report**

Report Number: 590-CLEA-19-2

# 2020 Natural Environment Existing Conditions

Chatham X Lakeshore 230 kV Transmission Line Project Class EA

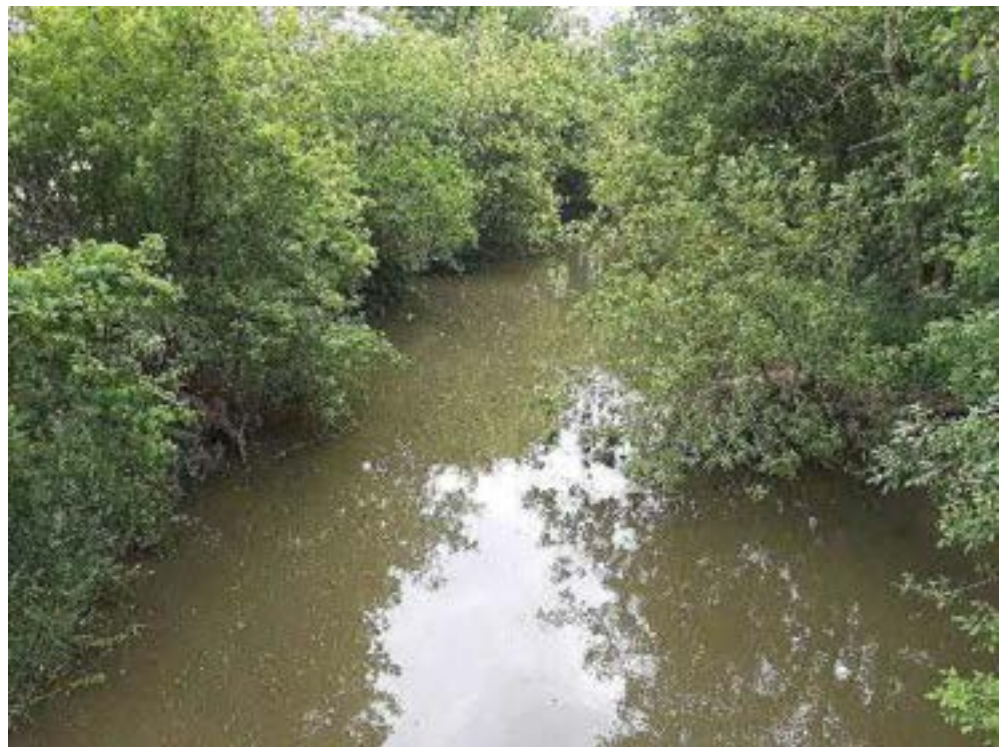
Ferguson Drain  
(Jeannettes  
Creek), facing  
downstream  
(west) north of  
Highway  
401. Photo taken  
from an  
agricultural  
crossing  
approximately  
120 m upstream  
of the potential  
corridor  
crossing.

Alt2_S19	42.339947	-82.205644	Ferguson Drain (Jeannettes Creek)	--	Muck, Detritus, Clay	20	25	1	Woody Debris, Organic Debris, Macrophytes	F, A	A, F	Open	F	Slow flow, turbid conditions, too deep to wade, abundant riparian shade, numerous YOY fish observed	Direct – fish observed	28
Alt2_S20	42.319989	-82.264179	Finn & Cooper Drain	Municipal Drain	Detritus, Clay	12	40	2	Woody Debris, Organic Debris, Undercut Banks	M	M	Open	E	Wide, deep, no flow, too deep to wade, great than 1 m depth	Direct based on DFO classification	29
Alt2_S21	42.235899	-82.552603	6-7 Sideroad Drain	Municipal Drain	--	--	--	--	--	--	--	Piped	F	No feature present as mapped (assumed piped).	No	30
Route Alternative 3 (Alt3)																
Alt3_S2	42.348992	-82.146989	Duke Drain (Jeannettes Creek)	Municipal Drain	Gravel <sup>1</sup> , Clay, Silt, Boulder, Cobble	1.8	8	0.15	Boulders/Cobble, Organic Debris, Macrophytes	M, C, A	M, C	Open	E	Very minor flow, culvert pool present, many small fish and crayfish observed	Direct – fish observed	31

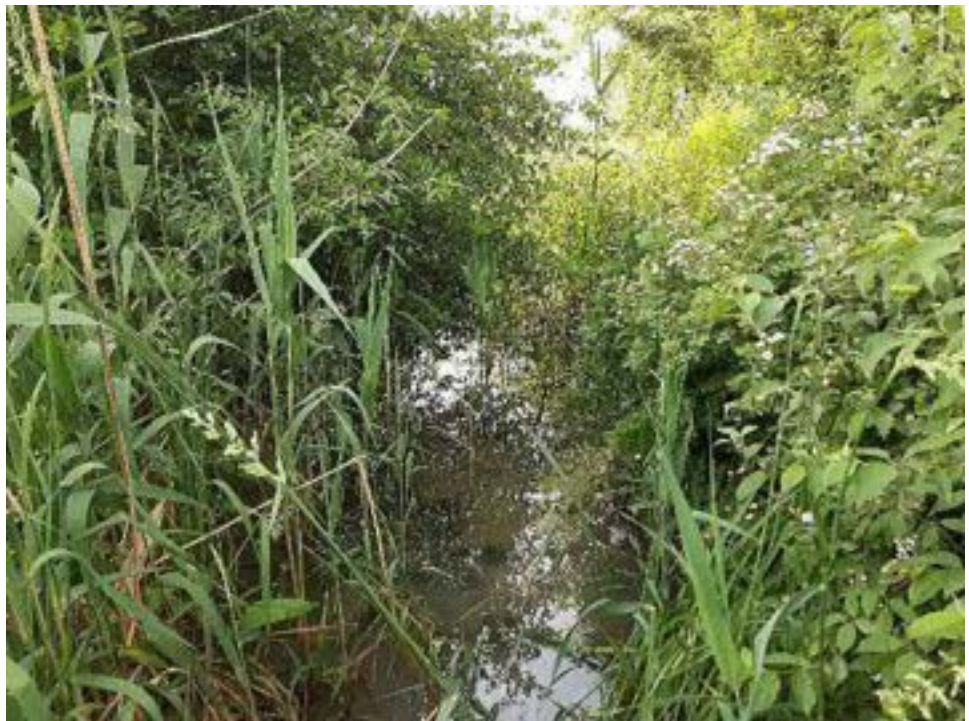
O'Rourke Drain,  
facing upstream  
(southeast), at  
the 9<sup>th</sup> Line  
crossing.

Alt3_S3	42.31581	-82.195385	O'Rourke Drain	Municipal Drain	Muck <sup>1</sup> , Detritus <sup>1</sup> , Clay	1.6	5	0.15	Woody Debris, Organic Debris, Macrophytes	M, C	M	Open	F	No flow, muck substrate, abundant instream vegetation	Seasonal based on DFO classification	32
Alt3_S4	42.299082	-82.212131	Carter Drain	--	Gravel <sup>1</sup> , Clay, Detritus, Cobble, Boulder	2	5	0.18	Macrophytes, Undercut Banks, Boulders, Organic Debris	S, C	S, C	Open	NR	No flow, firm substrate, abundant algae, numerous small fish observed	Direct – fish observed	33
Alt3_S5	42.287922	-82.235961	Kersey Drain	Municipal Drain	Gravel <sup>1</sup> , Clay <sup>1</sup> , Detritus	2.25	7	0.2	Macrophytes, Woody Debris	M, A	A, M	Open	E	No flow, turbid conditions, abundant algae, no fish observed	Direct based on DFO classification	34
Alt3_S6	42.262798	-82.300757	Deary Drain	Municipal Drain	Clay <sup>1</sup> , Gravel <sup>1</sup> , Detritus	6	15	0.2	Boulders, Cobble, Woody Debris, Macrophytes, Organic Debris	M, A	M, A	Open	NR	Wide, slow flow, turbid conditions, abundant algae, no fish observed	Likely direct	35

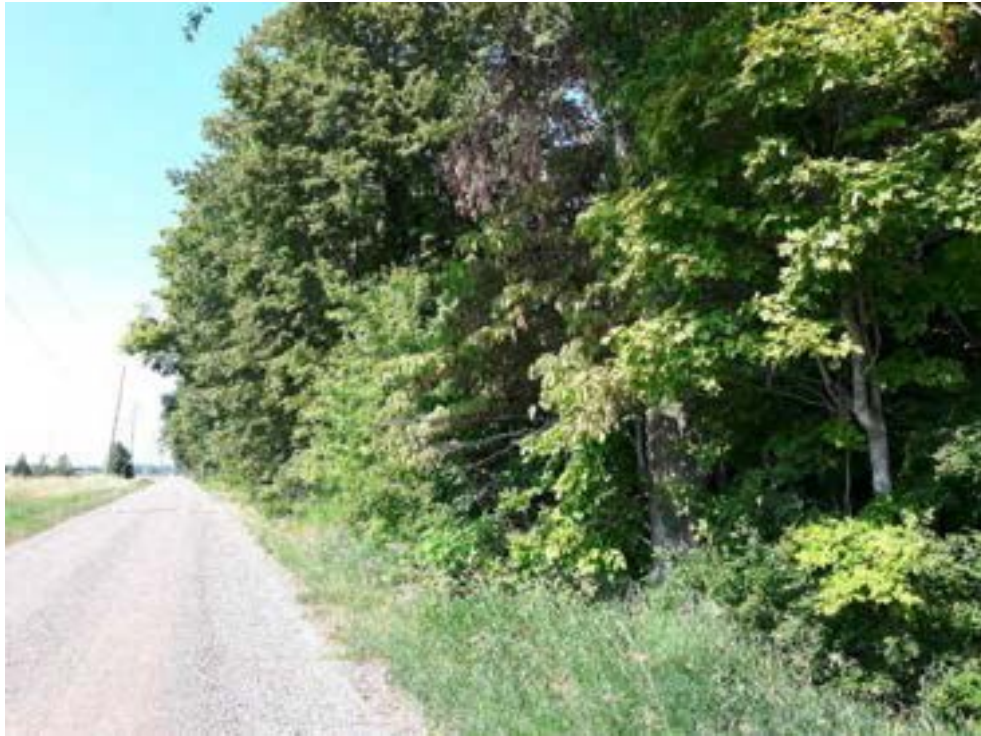
Photograph 50

Looking  
southwest  
towards Fresh-  
Moist Sugar  
Maple White  
Elm Deciduous  
Forest Type.

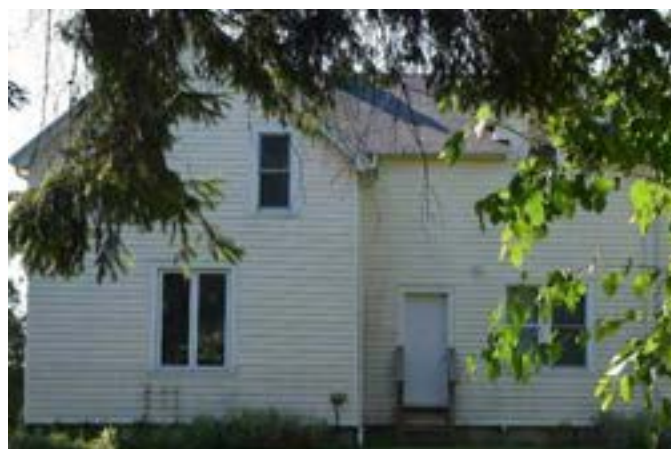
## 8319 SEVENTH LINE EAST, CHATHAM

*South (front) façade of house on property*

**Heritage Status:** Property of potential CHVI

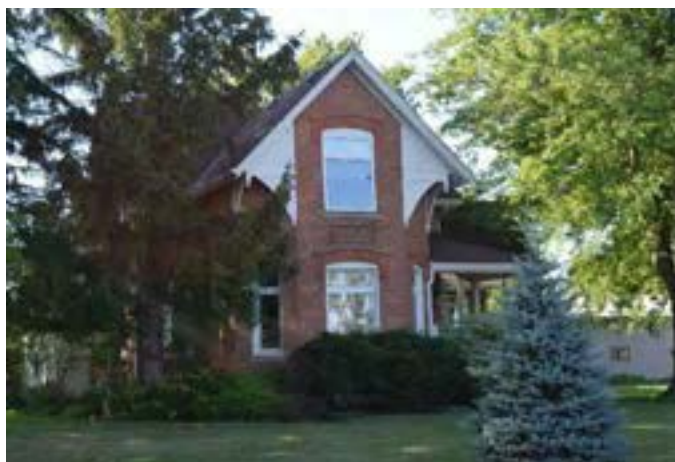
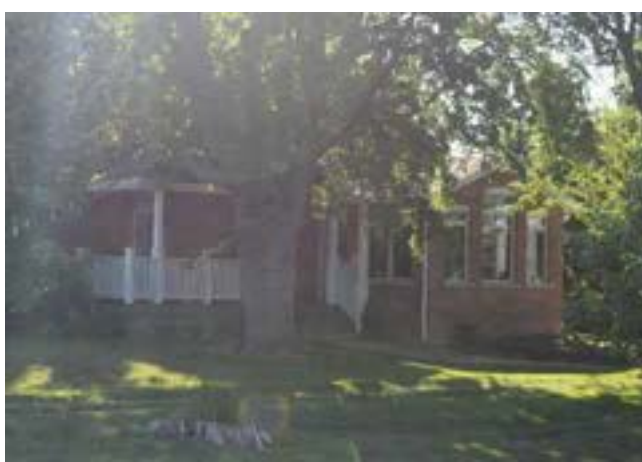
## 8075 SEVENTH LINE EAST, CHATHAM

*South (front) façade of house on property*

*East wall of house on property*

**Heritage Status:** Property of potential CHVI

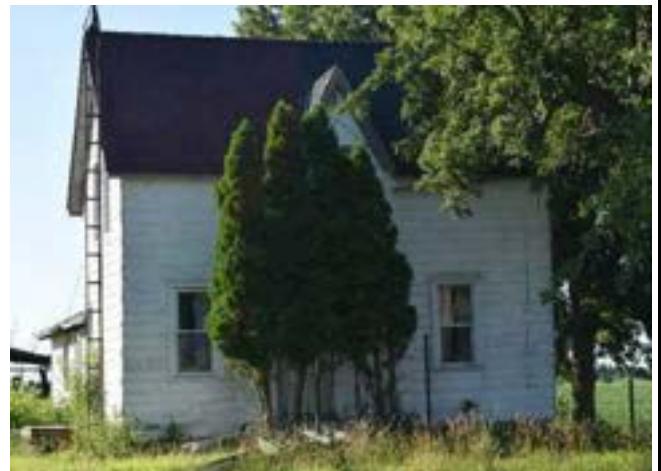
## 8019 SEVENTH LINE EAST, CHATHAM

*Property lot, looking northeast from Seventh Line East*

*Property lot, looking north from Seventh Line East*

*Associated open air barn on property, looking north from Seventh Line East*

*South (front) façade of house on property*

**Description:** *Built heritage resource* – Single detached, storey-and-a-half, vinyl siding clad house and associated rear (north) barn. The house has a three-bay main block with symmetrical fenestration and a medium pitch gable roof with a centre gable on the south (front) façade exhibiting a decorated fascia (damaged, partially missing). It has a rectangular plan with a one-storey extension to the north.

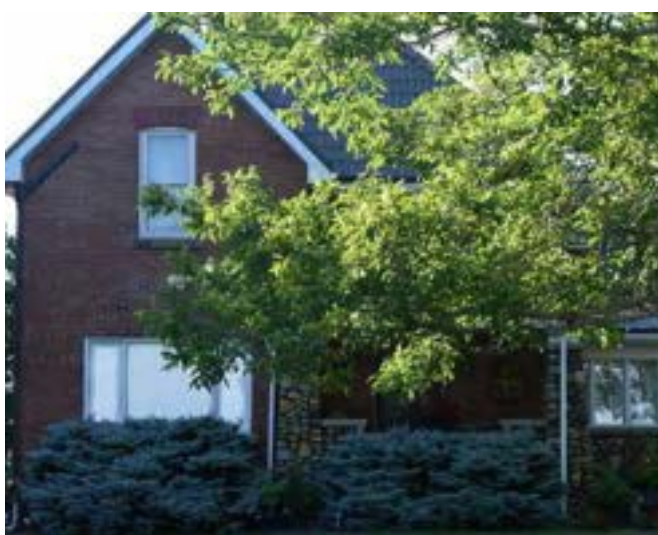
## 7867 6 LINE EAST, CHATHAM

*South (front) façade of house on property*

**Heritage Status:** Property of potential CHVI

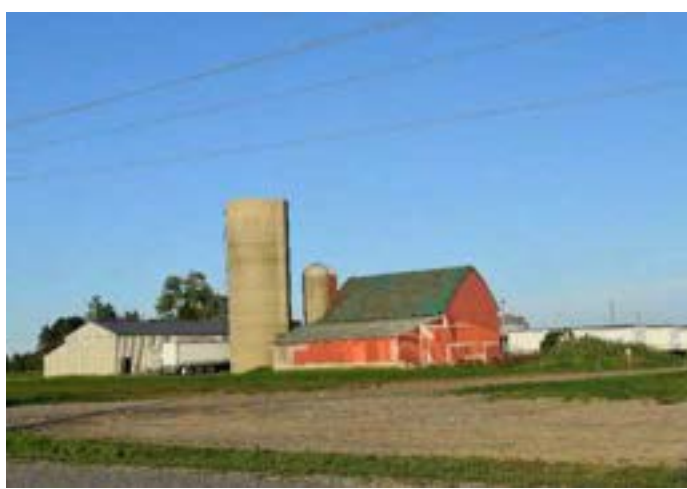
Associated barns on property, looking south from 5 Line East

**Heritage Status:** Property of potential CHVI

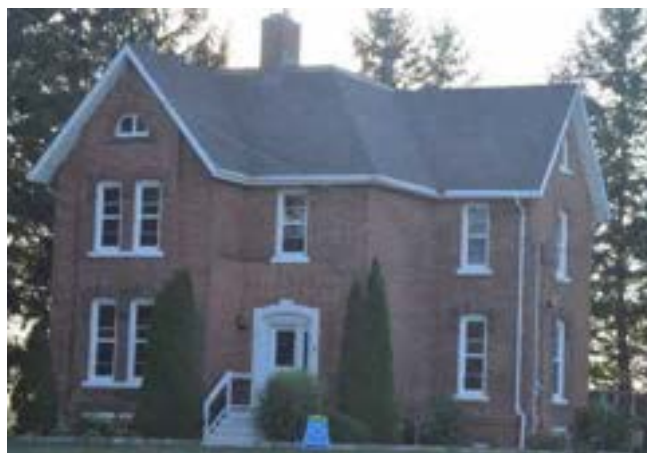
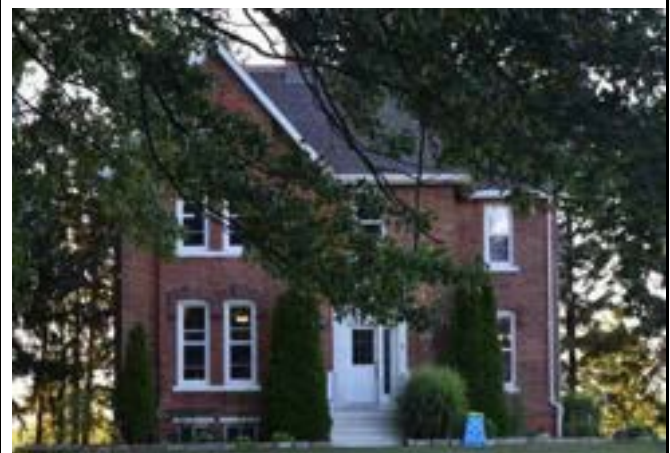
## 7617 5 LINE EAST, CHATHAM

*South (front) façade and west wall of house on property*

*South (front) façade of house on property*

**Heritage Status:** Property of potential CHVI

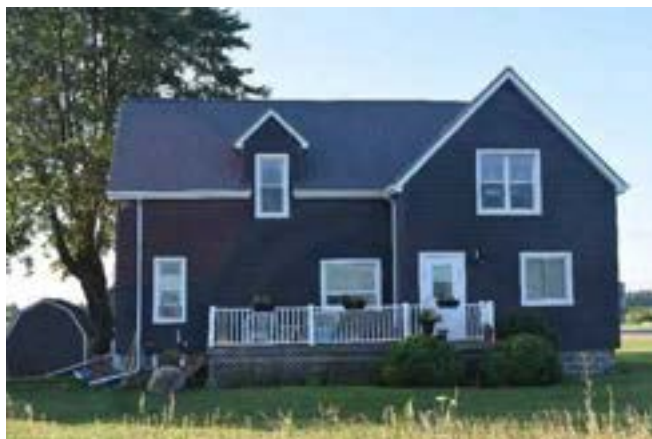
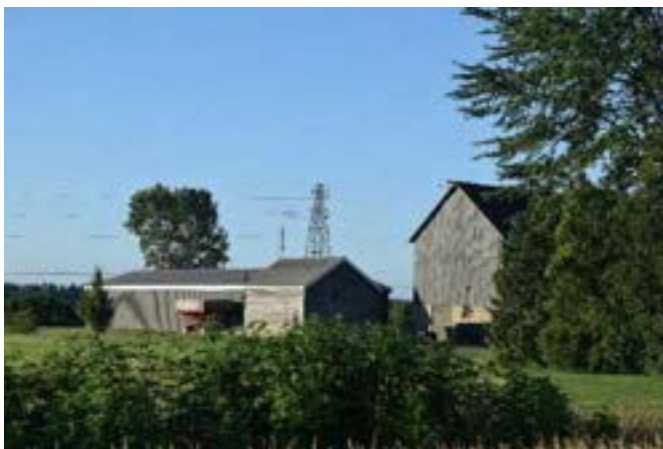
## 6730 3 LINE, CHATHAM

*North (front) façade of house on property*

*Associated barn and outbuilding on property, looking southwest from 3 Line*

**Heritage Status:** Property of potential CHVI

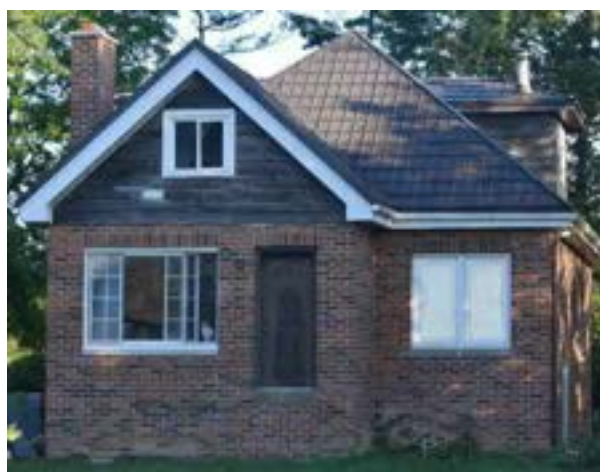
## 6481 3 LINE, CHATHAM

*South (front) façade of house on property*

**Heritage Status:** Property of potential CHVI

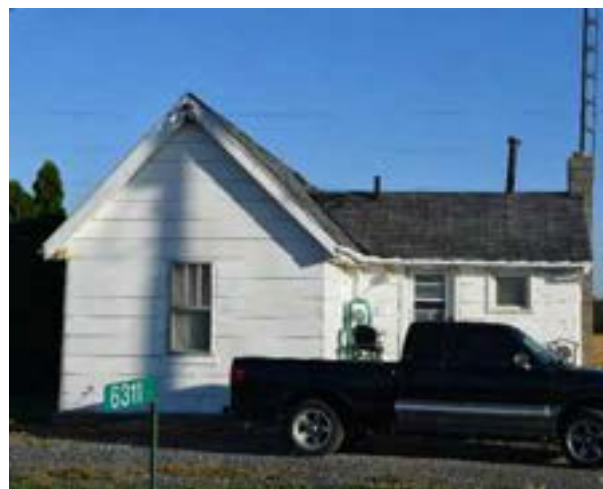
## 6311 3 LINE, CHATHAM

*South (front) façade of house on property*

**Heritage Status:** Property of potential CHVI

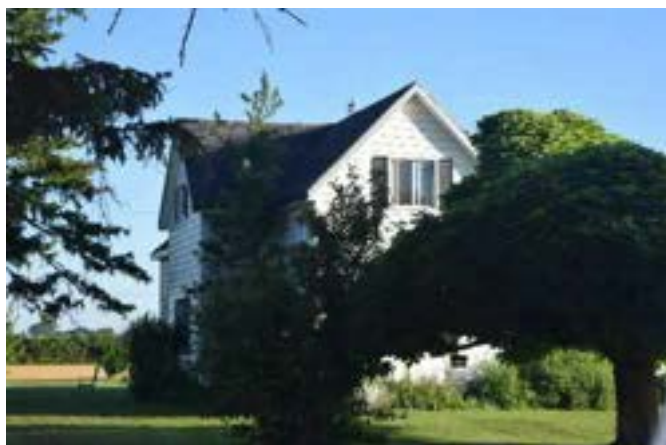
## 6281 3 LINE, CHATHAM

*South (front) façade and west wall of house on property*

**Heritage Status:** Property of potential CHVI

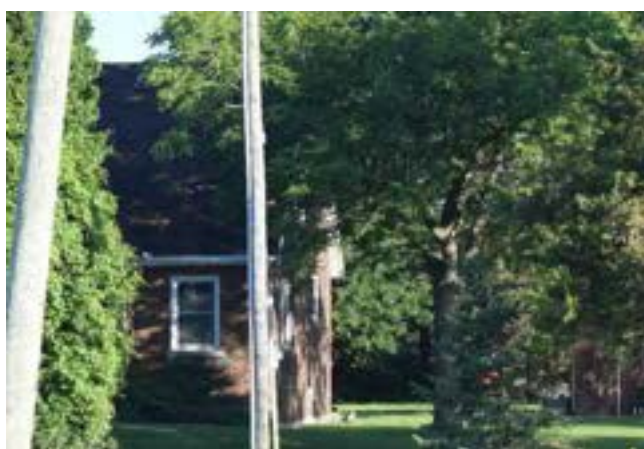
## 6623 QUEEN'S LINE, CHATHAM

*South (front) façade and east wall of house on property*

**Heritage Status:** Property of potential CHVI

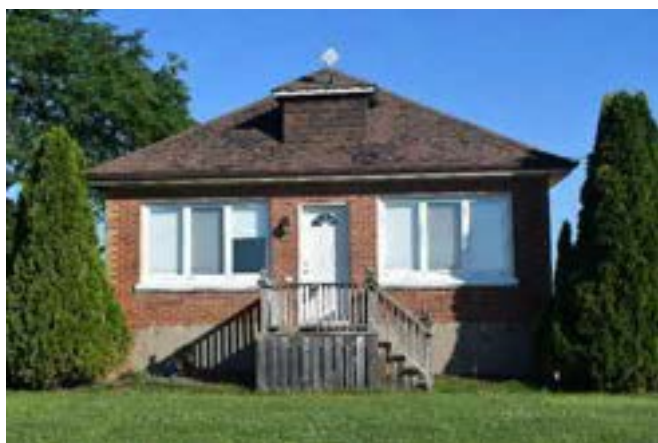
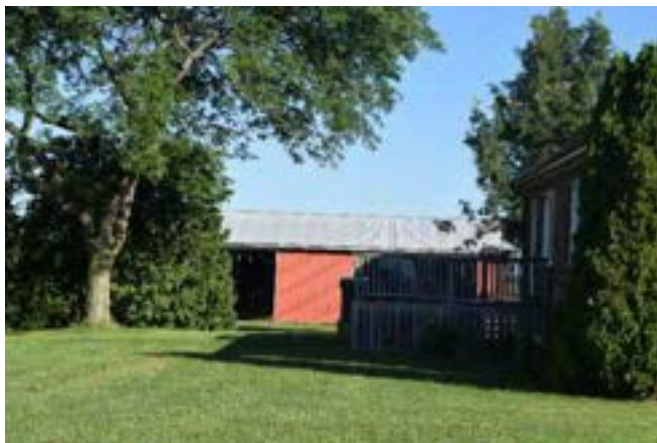
## 6155 3 LINE, CHATHAM

*South (front) façade of house on property*

*Associated barn on property, looking north from 3 Line*

**Heritage Status:** Property of potential CHVI

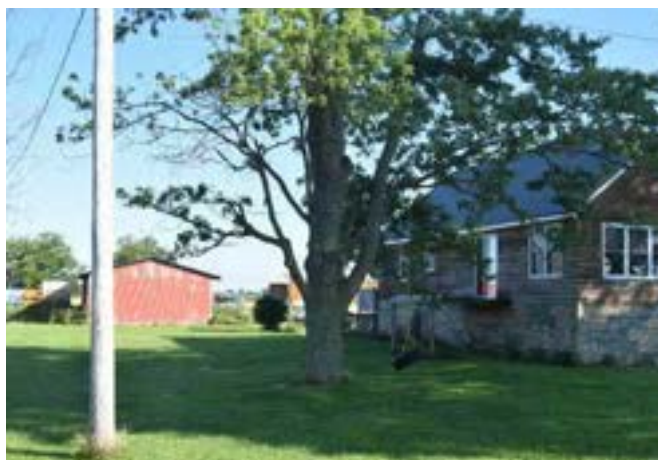
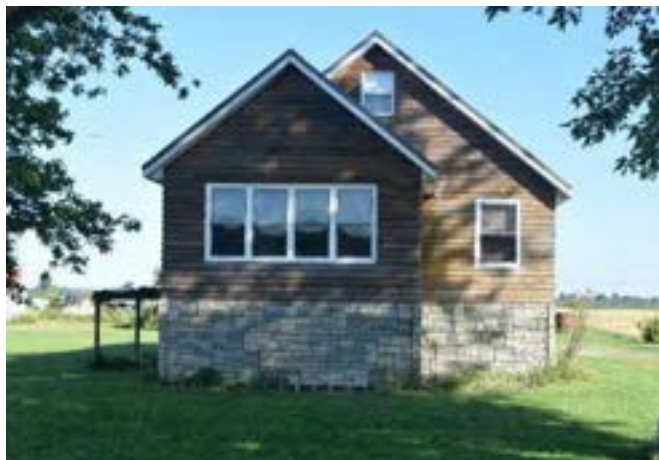
## 6085 3 LINE, CHATHAM

*Property lot, looking northeast from Queen's Line*

*South façade of house on property*

**Description:** *Built heritage resource* – Single detached, storey-and-a-half, log house with associated rear (north) outbuildings. The house has a three-bay main block with a medium pitch gable roof. It has a rectangular plan, of which the west (front) façade is located along the wider axis, and no major extensions. Walls and foundation appear to have been recently refaced/ refinished.

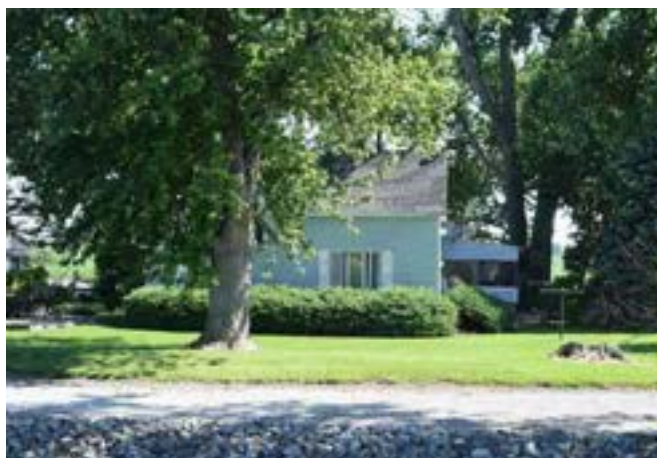
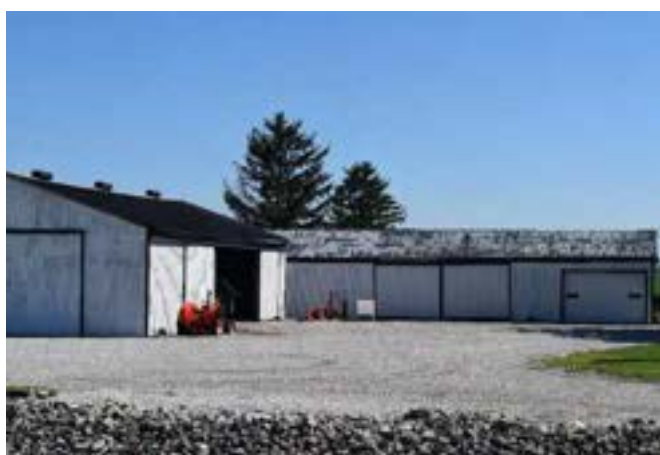
## 24003 DAUPHIN ROAD, TILBURY

*West wall of house on property*

*Associated barns on property, looking northeast from Dauphin Road*

**Heritage Status:** Property of potential CHVI

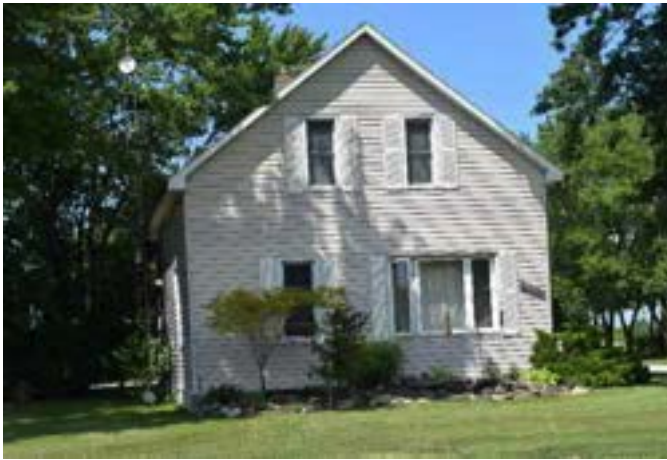
## 21500 LAKESHORE ROAD 303, TILBURY

*South (front) façade of house on property*

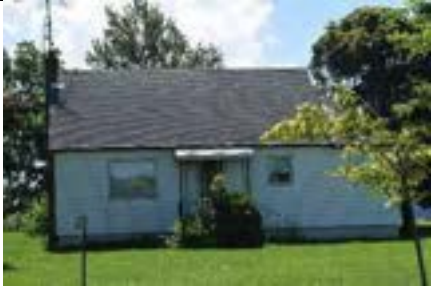
Address	Image	Brief Description	CHVI Status
4288 Forbes Line, Tilbury

Single detached, one-storey, vinyl siding clad house with one-storey extension to south and associated metal outbuildings and silo to west. Not visible on early 20th century topographical mapping.	The property does not contain CHVI as it exhibits common architectural styles and materials, demonstrates an average level of construction expertise, and has no historical associations.
24029 Dashwheel Road, Tilbury

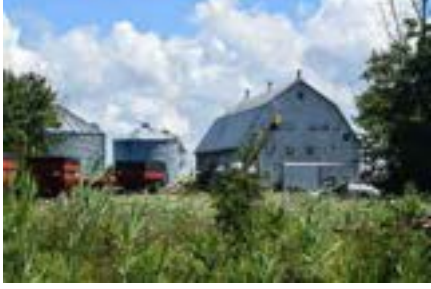
Obstructed by tree cover but property does not appear to have residential dwelling, instead it has a collection of one large gambrel roof barn, now faced with metal siding, one metal outbuilding, one small wooden shed and two silos. Not visible on early 20th century topographical mapping.	The property does not contain CHVI as it exhibits common architectural styles and materials, demonstrates an average level of construction expertise, and has no historical associations.

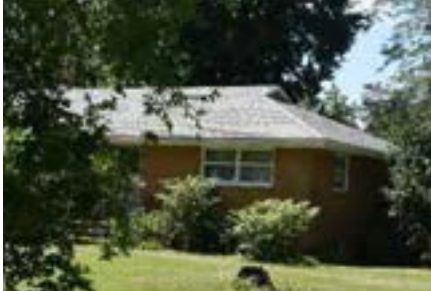
23846 Dashwheel Road, Tilbury

Single detached, one-storey bungalow, brick house with metal barn and silos to west. Not visible on early 20th century topographical mapping.	The property does not contain CHVI as it exhibits common architectural styles and materials, demonstrates an average level of construction expertise, and has no historical associations.
4109 Mint Line, Tilbury

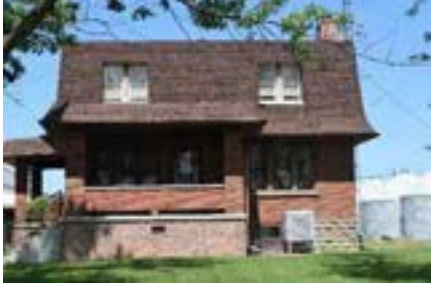
Single detached, two-storey, brick house with open porch. Metal outbuildings and silos to north. Not visible on early 20th century topographical mapping.	The property does not contain CHVI as it exhibits common architectural styles and materials, demonstrates an average level of construction expertise, and has no historical associations.
3762 Mint Line, Tilbury

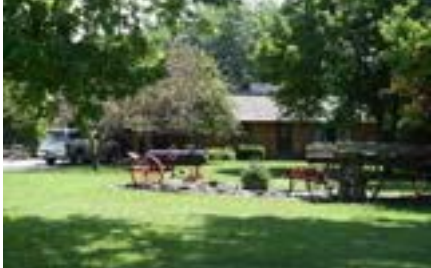
Single detached, storey-and-a-half, brick and vinyl siding clad house. Earlier wooden structure visible near property on 20 <sup>th</sup> topographical mapping, however, is most likely neighbouring property at 3734	The property does not contain CHVI as it exhibits common architectural styles and materials, demonstrates an average level of construction

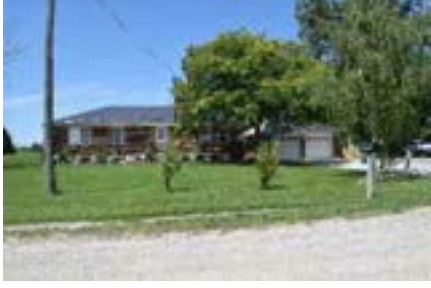
Single detached, one-storey bungalow, brick house with detached garage. Not visible on early 20th century topographical mapping.	The property does not contain CHVI as it exhibits common architectural styles and materials, demonstrates an average level of construction expertise, and has no historical associations.
3814 Mint Line, Tilbury

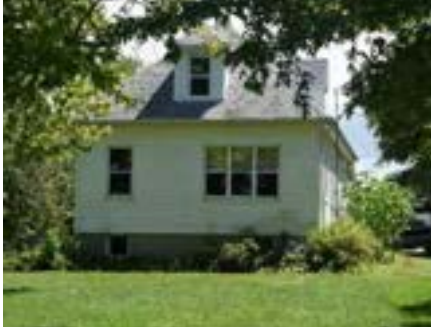
Single detached, storey-and-a-half, vinyl siding clad house. Earlier wooden structure constructed on property by early 20th century topographical mapping.	The property does not contain CHVI as it exhibits common architectural styles and materials, demonstrates an average level of construction expertise, and has no historical associations.
2825 Baptiste Road, Tilbury

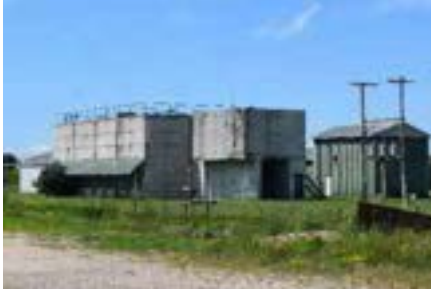
Concrete industrial building for Roden Manufacturing. Appears to have been decommissioned in favour of newer metal buildings to north. Not visible on early 20th century topographical mapping.	The property does not contain CHVI as it exhibits common architectural styles and materials, demonstrates an average level of construction expertise, and has no historical associations.

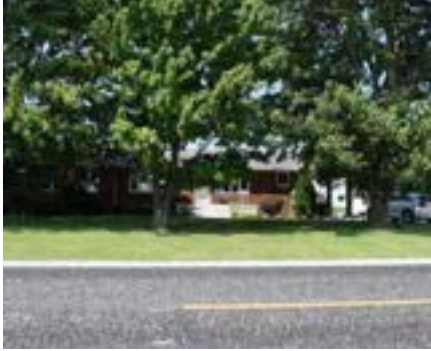
22100 Lakeshore Road 303, Tilbury

Single detached, one-storey bungalow, brick house. Earlier wooden house constructed further east on the property by early 20th century topographical mapping, however, it appears to have been demolished as current house exhibits all new construction.	The property does not contain CHVI as it exhibits common architectural styles and materials, demonstrates an average level of construction expertise, and has no historical associations.

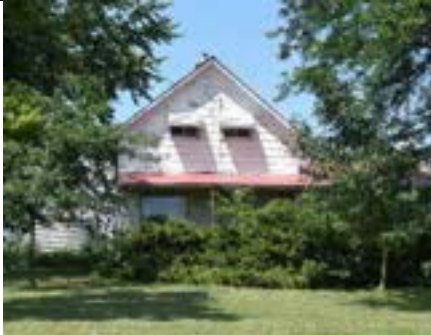
Single detached, storey-and-a-half, vinyl siding clad house with a large extension to the east. Not visible on early 20th century topographical mapping.	The property does not contain CHVI as it exhibits common architectural styles and materials, demonstrates an average level of construction expertise, and has no historical associations.
20925 Lakeshore Road 303, Tilbury

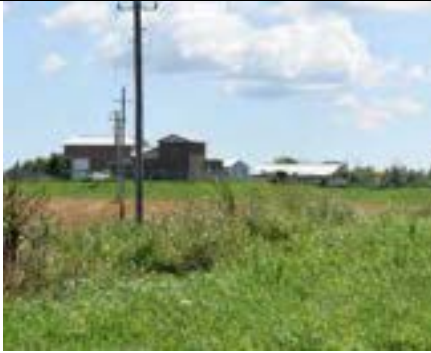
Large industrial metal structures associated with the Tilbury Wastewater Treatment Plant. Earlier narrow wooden structure constructed much further north on the property by early 20th century topographical mapping, however, it appears to have been demolished	The property does not contain CHVI as it exhibits common architectural styles and materials, demonstrates an average level of construction expertise, and has no historical associations.

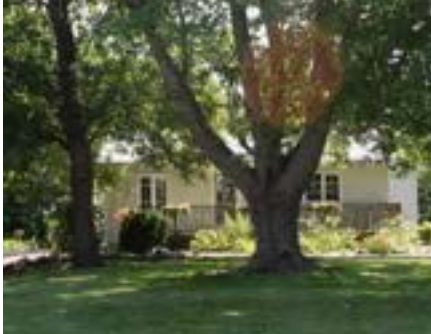
20725 Lakeshore Road 303, Tilbury

Single detached, one-storey, vinyl siding clad house with one-storey extension to south and associated metal barn and silo to south. Not visible on early 20th century topographical mapping.	The property does not contain CHVI as it exhibits common architectural styles and materials, demonstrates an average level of construction expertise, and has no historical associations.
20300 Lakeshore Road 303, Tilbury

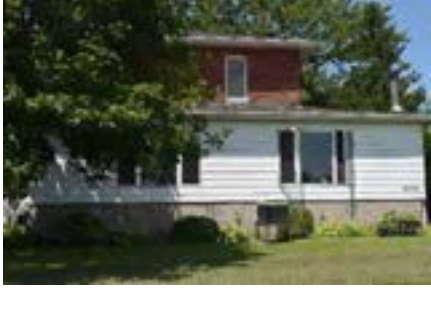
Single detached, two-storey, brick and vinyl siding clad house. Vinyl siding clad appears to be one storey extension on north, south and east façades of brick house. Wooden shed and metal outbuilding to north. Not visible on early 20th century topographical mapping.	The property does not contain CHVI as it exhibits common architectural styles and materials, demonstrates an average level of construction expertise, and has no historical associations.

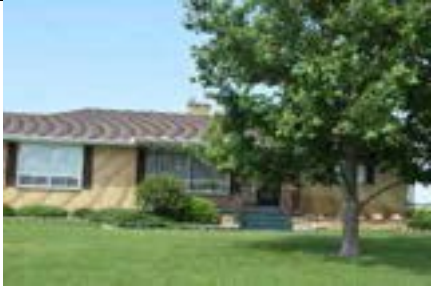
Address	Image	Brief Description	CHVI Status
16300 County Road 42, Tilbury

Single detached, one-storey bungalow, brick house with gambrel roof metal barn and associated complex of metal outbuildings to west. Not visible on early 20th century topographical mapping.	The property does not contain CHVI as it exhibits common architectural styles and materials, demonstrates an average level of construction expertise, and has no historical associations.
11401 Morris Road, Comber

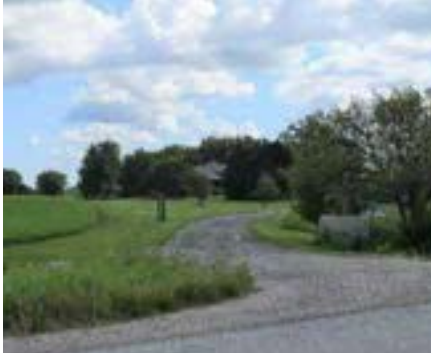
Single detached, one-storey bungalow, brick house with gambrel roof metal barn and associated complex of metal outbuildings to west. Not visible on early 20th century topographical mapping.	The property does not contain CHVI as it exhibits common architectural styles and materials, demonstrates an average level of construction expertise, and has no historical associations.
9503 Morris Road, Comber

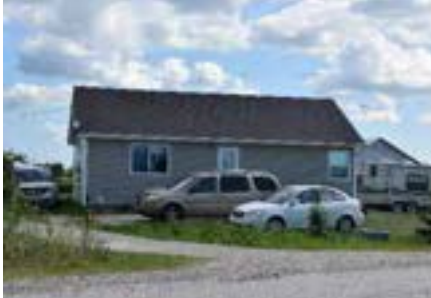
Single detached, one-storey, vinyl siding clad and associated metal outbuilding to south. Not visible on early 20th century topographical mapping.	The property does not contain CHVI as it exhibits common architectural styles and materials, demonstrates an average level of construction expertise, and has no historical associations.

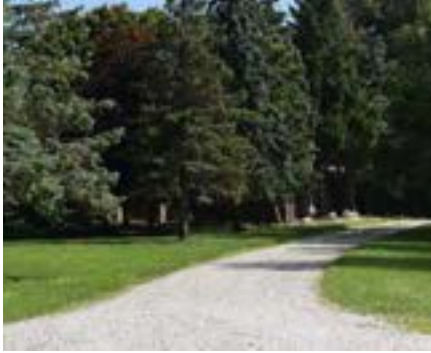
8309 Morris Road, Comber

Single detached, one-storey bungalow, brick house with gambrel roof metal barn and associated complex of metal outbuildings to west. Initial wooden house constructed on the property by early 20th century topographical mapping, however, it appears to have been demolished as current house exhibits all new construction.	The property does not contain CHVI as it exhibits common architectural styles and materials, demonstrates an average level of construction expertise, and no longer has any historical associations.

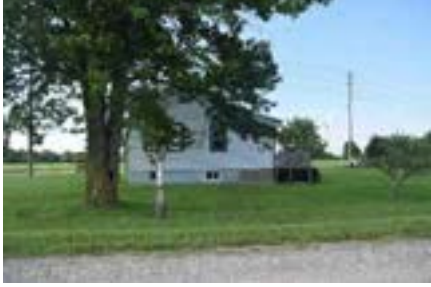
Single detached, storey-and-a-half, vinyl siding clad house. Not visible on early 20th century topographical mapping.	The property does not contain CHVI as it exhibits common architectural styles and materials, demonstrates an average level of construction expertise, and has no historical associations.

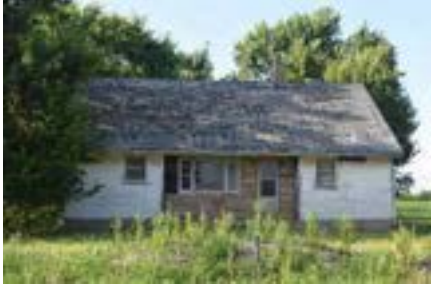
Single detached, one-storey, vinyl siding clad (and possible alternate siding) house with associated metal outbuildings to east. Not visible on early 20th century topographical mapping.	The property does not contain CHVI as it exhibits common architectural styles and materials, demonstrates an average level of construction expertise, and has no historical associations.

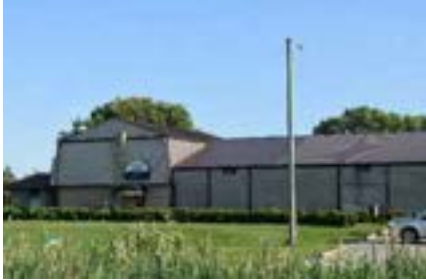
Address	Image	Brief Description	CHVI Status
20425 Middle Road, Comber

<p>Large brick and concrete building for Tilbury Gold Club with associated golf course to south. Initial wooden house constructed to west of property by early 20th century topographical mapping, however, it appears to have been demolished for golf course.</p>	<p>The property does not contain CHVI as it exhibits common architectural styles and materials, demonstrates an average level of construction expertise, and no longer has historical associations.</p>
20600 Middle Road, Comber

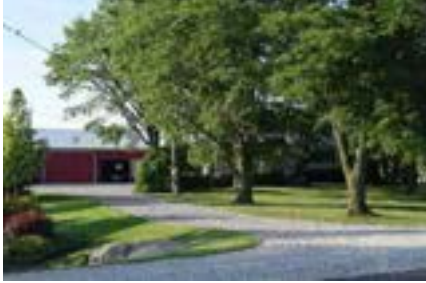
<p>Single detached, storey-and-a-half, vinyl siding clad house with associated metal outbuildings to north and east. Earlier wooden structure constructed on property by early 20th century topographical mapping.</p>	<p>The property does not contain CHVI as it exhibits common architectural styles and materials, demonstrates an average level of construction expertise, and has no historical associations.</p>

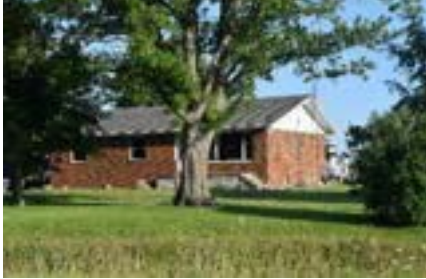
21225 Middle Road, Comber

<p>Single detached, one-storey bungalow, brick house with metal outbuildings and silos to north. Initial wooden house constructed on the property by early 20th century topographical mapping, however, it appears to have been demolished as current house exhibits all new construction.</p>	<p>The property does not contain CHVI as it exhibits common architectural styles and materials, demonstrates an average level of construction expertise, and no longer has historical associations.</p>
21625 Middle Road, Comber

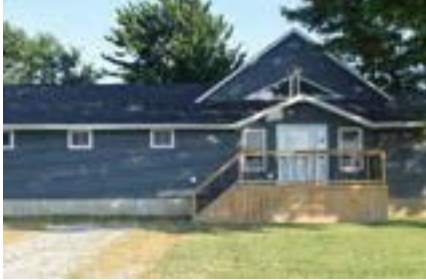
<p>Single detached, one-storey bungalow, vinyl siding clad house with large metal outbuildings to south. Appears to have been recently renovated. Earlier wooden structure constructed on property by early 20th century topographical mapping.</p>	<p>The property does not contain CHVI as it exhibits common architectural styles and materials, demonstrates an average level of construction expertise, and has no historical associations.</p>
