APPENDIX A: FIGURES

Client/Project
 2017 Annual Groundwater and
 Surface Water Monitoring Report,
 Hydro One - Clarington
 Transformer Station

Hydro One Networks Inc.
2017 Annual Groundwater and Surface
Water Monitoring Report

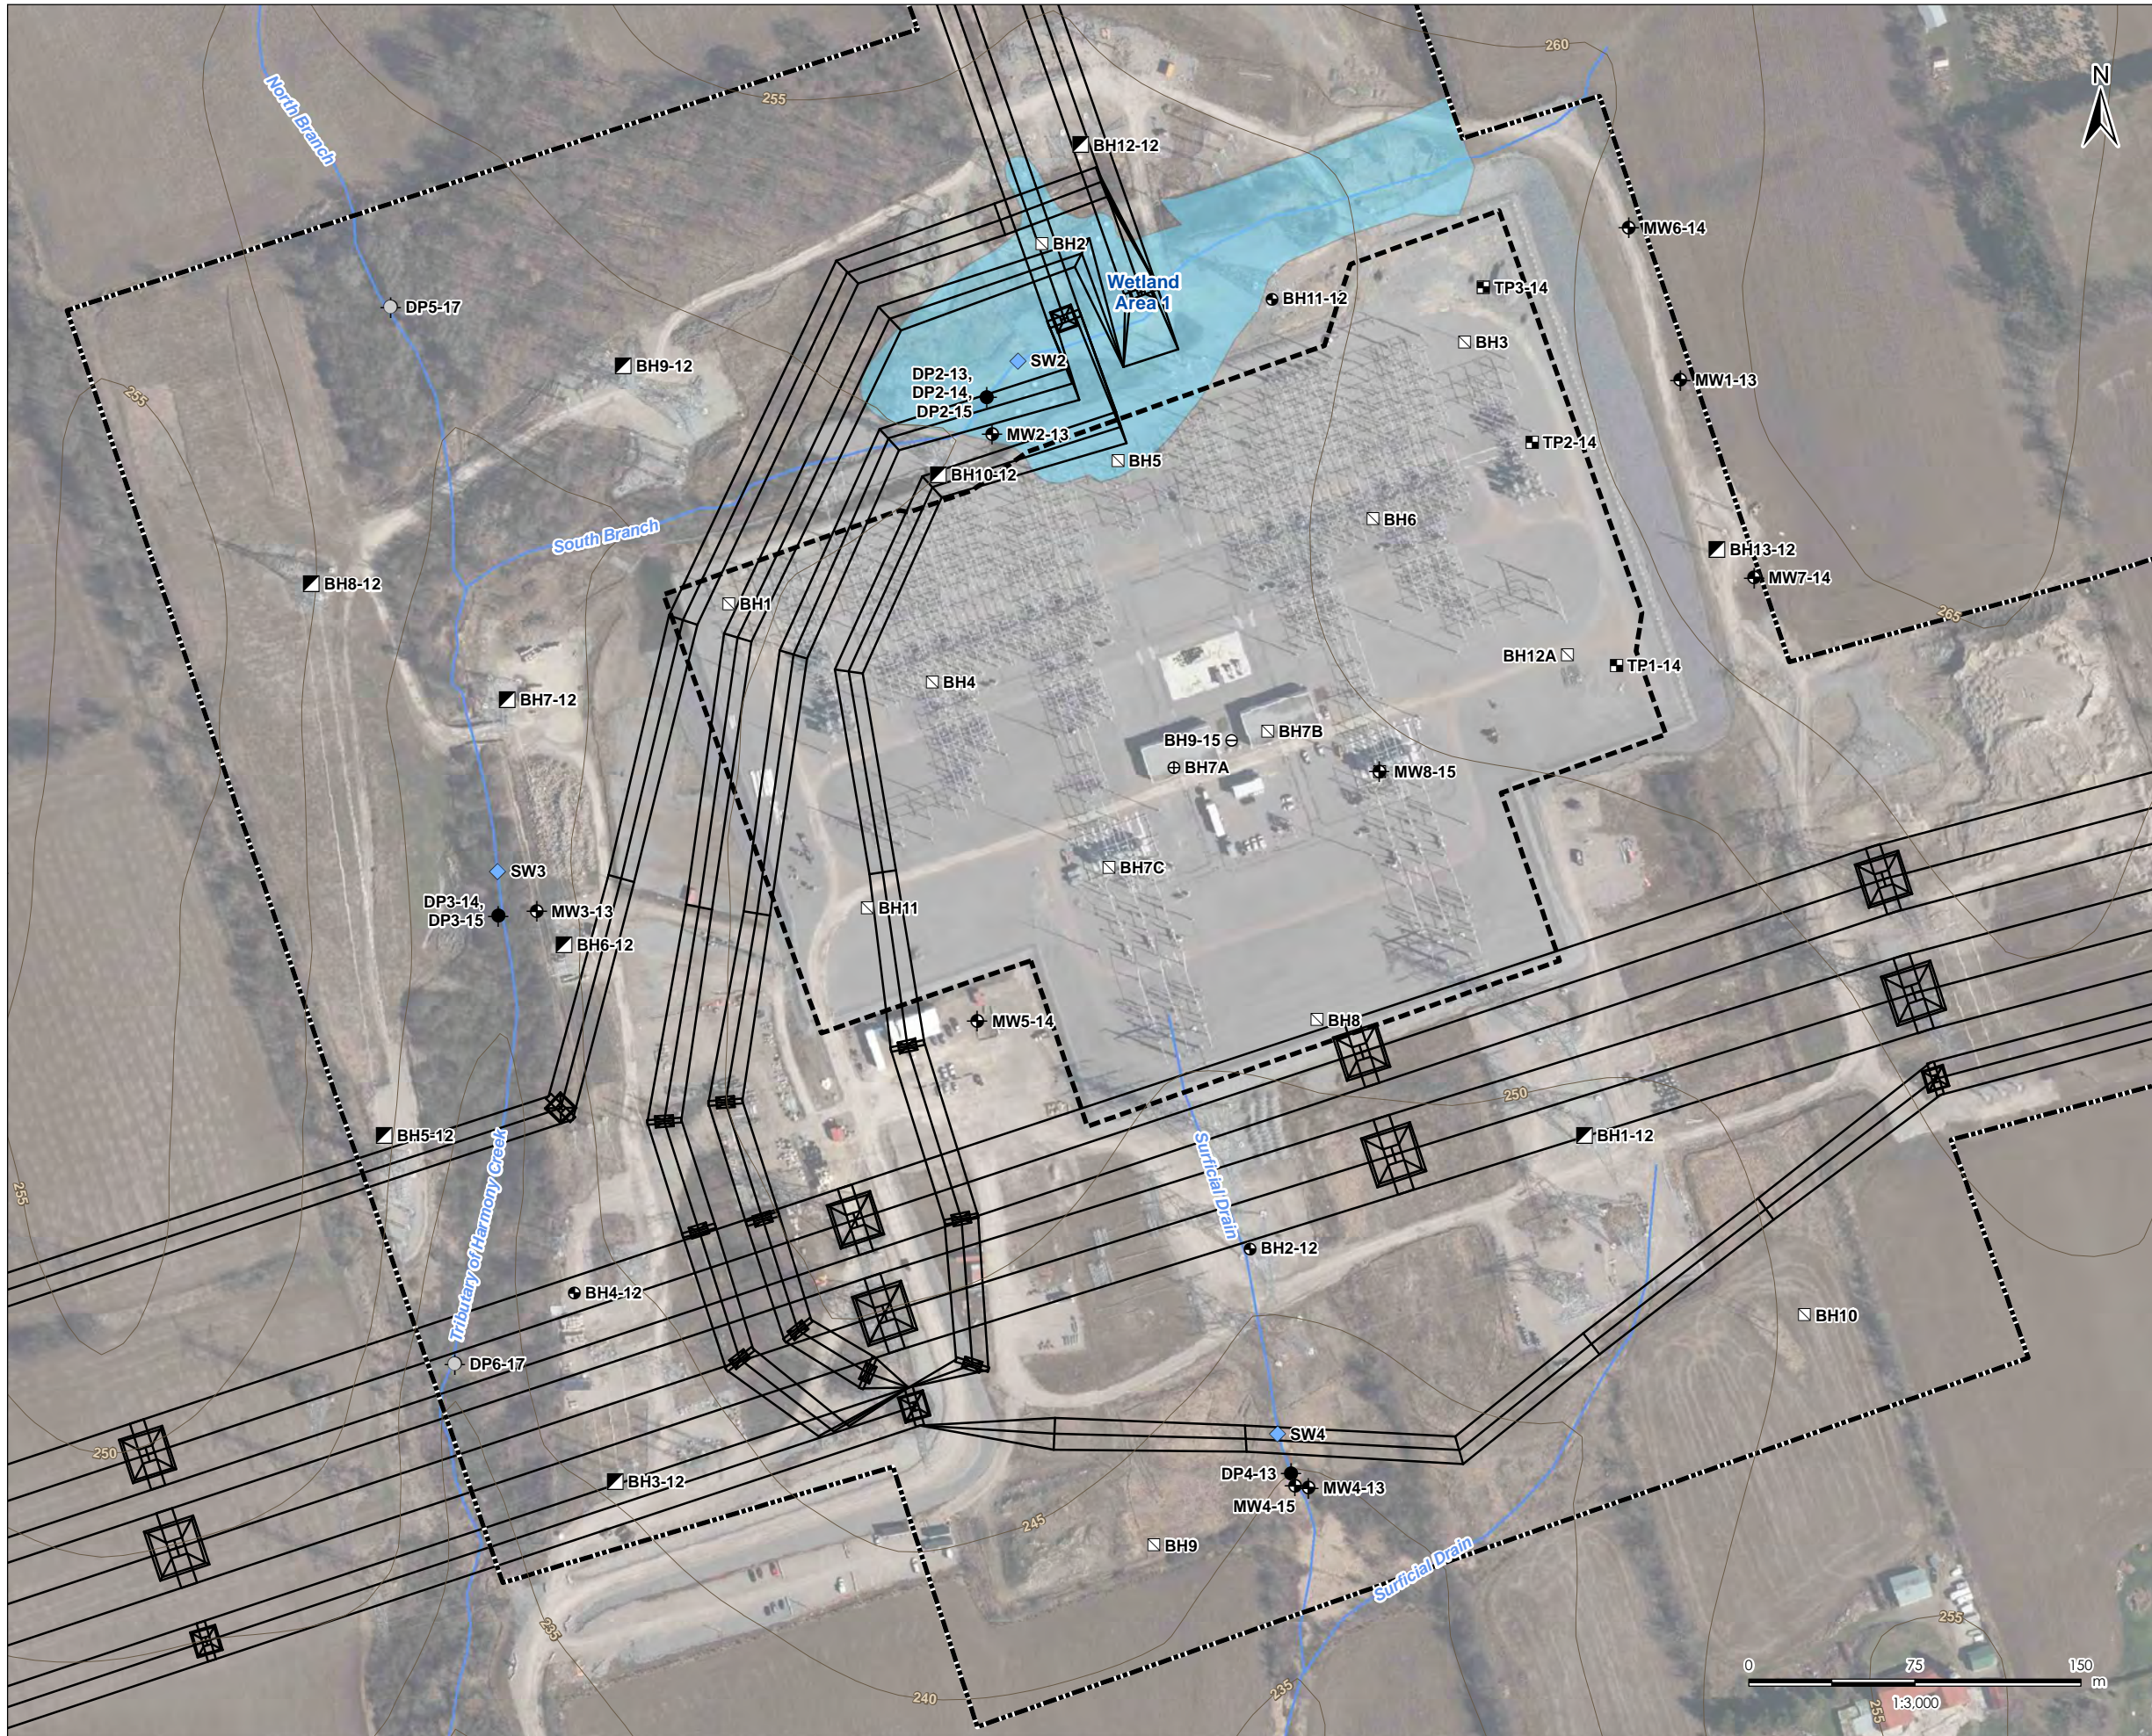
Figure No.
2

Title
Project Site Plan

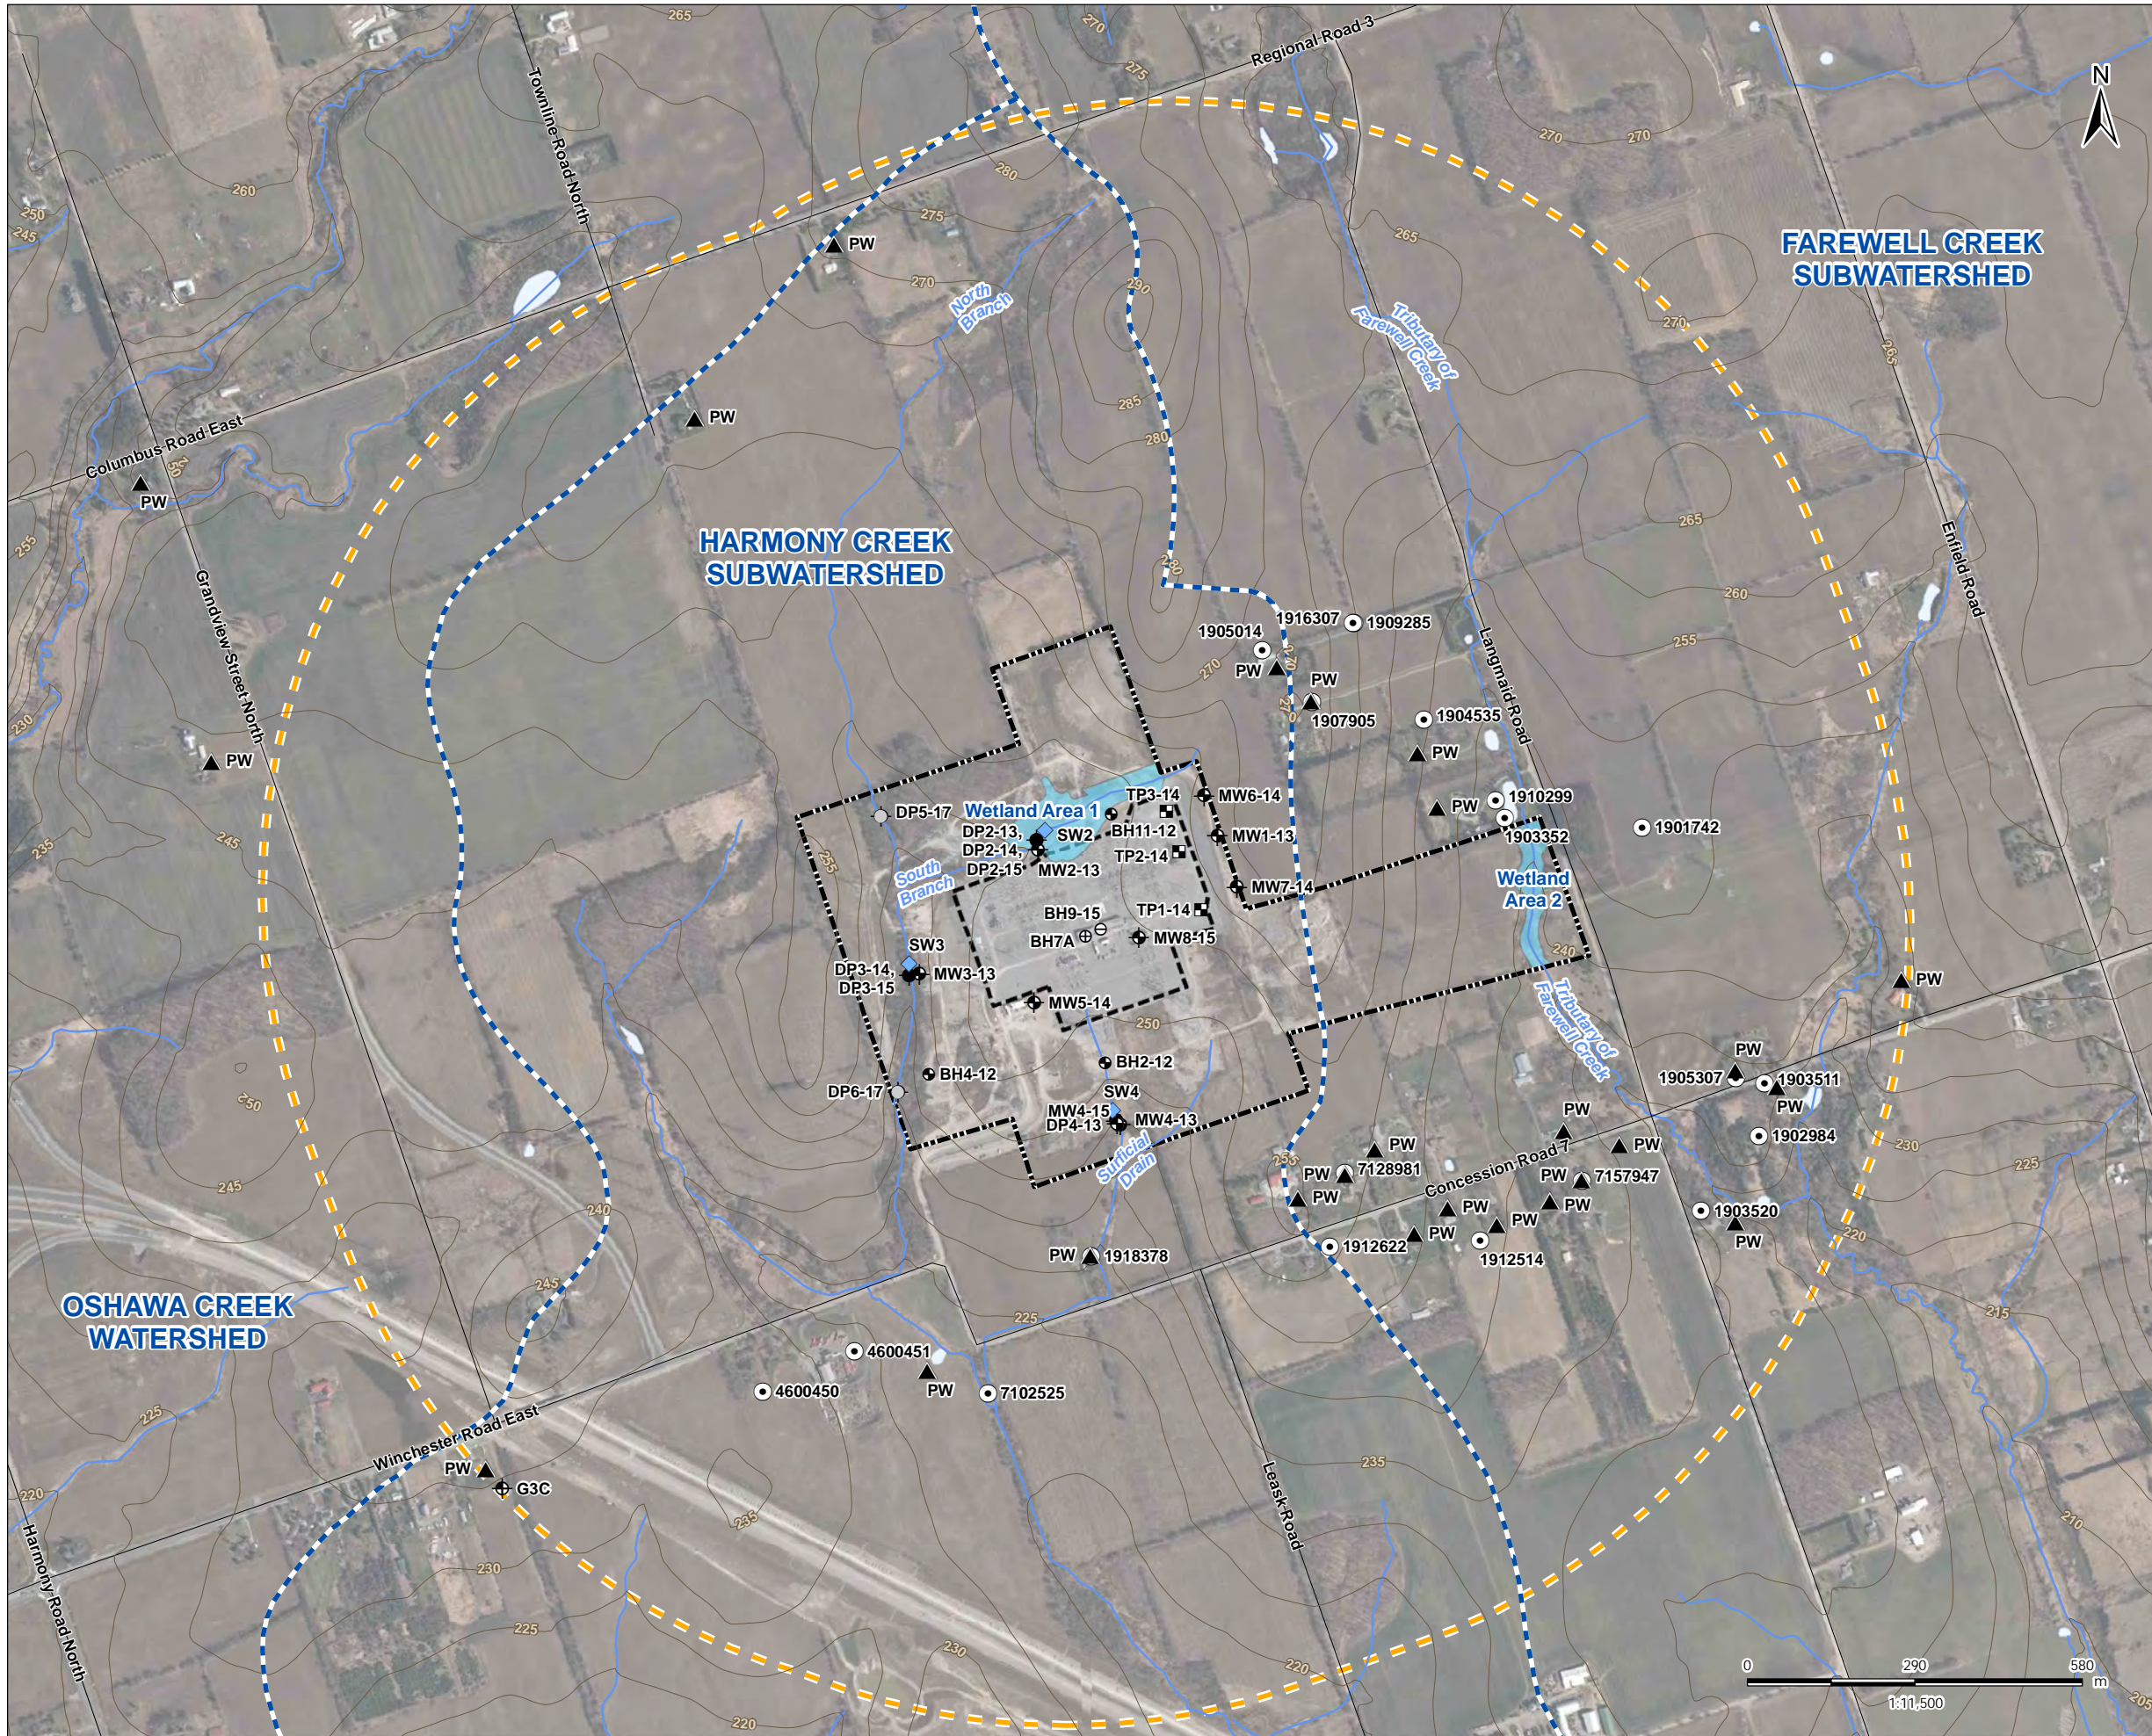
Figure No.
3

Title
Site Setting

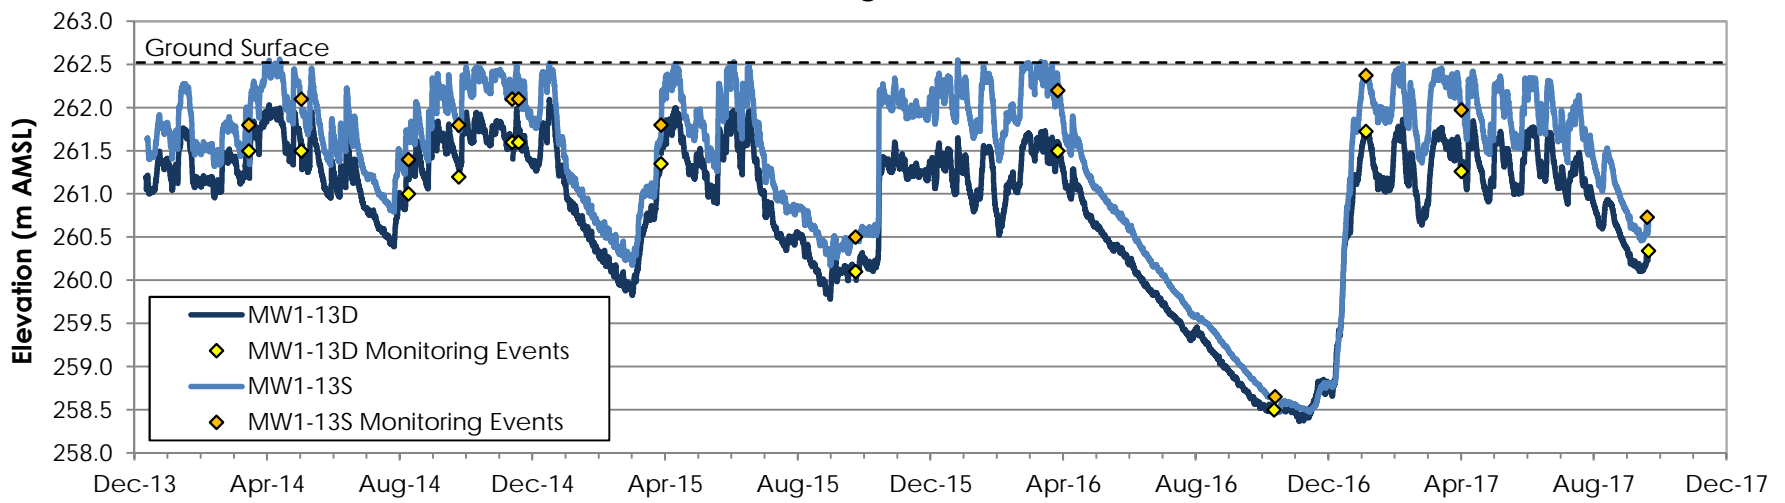
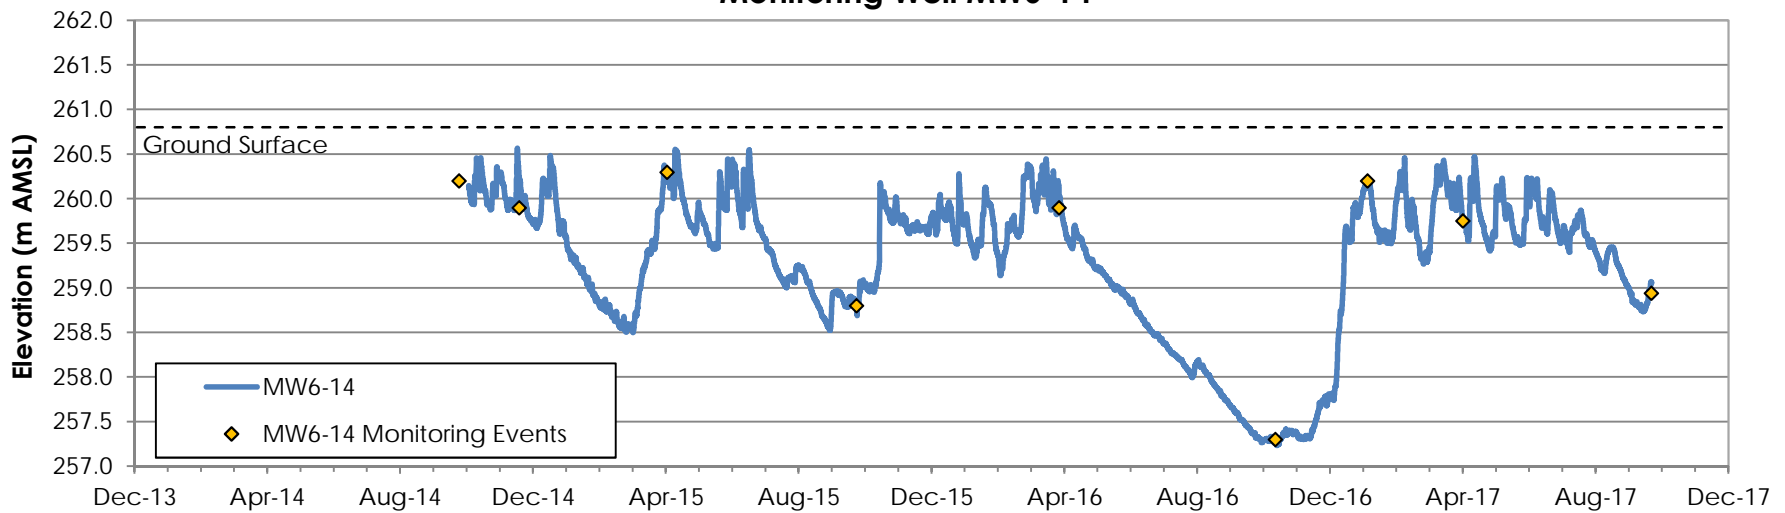
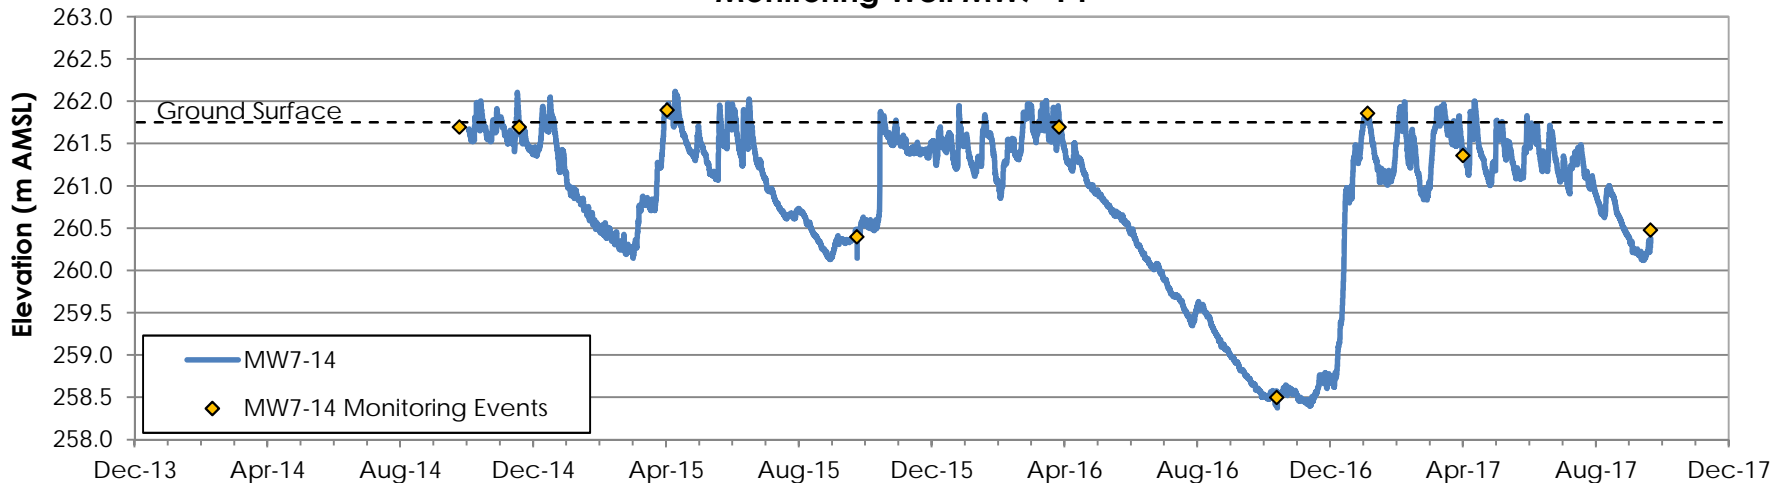
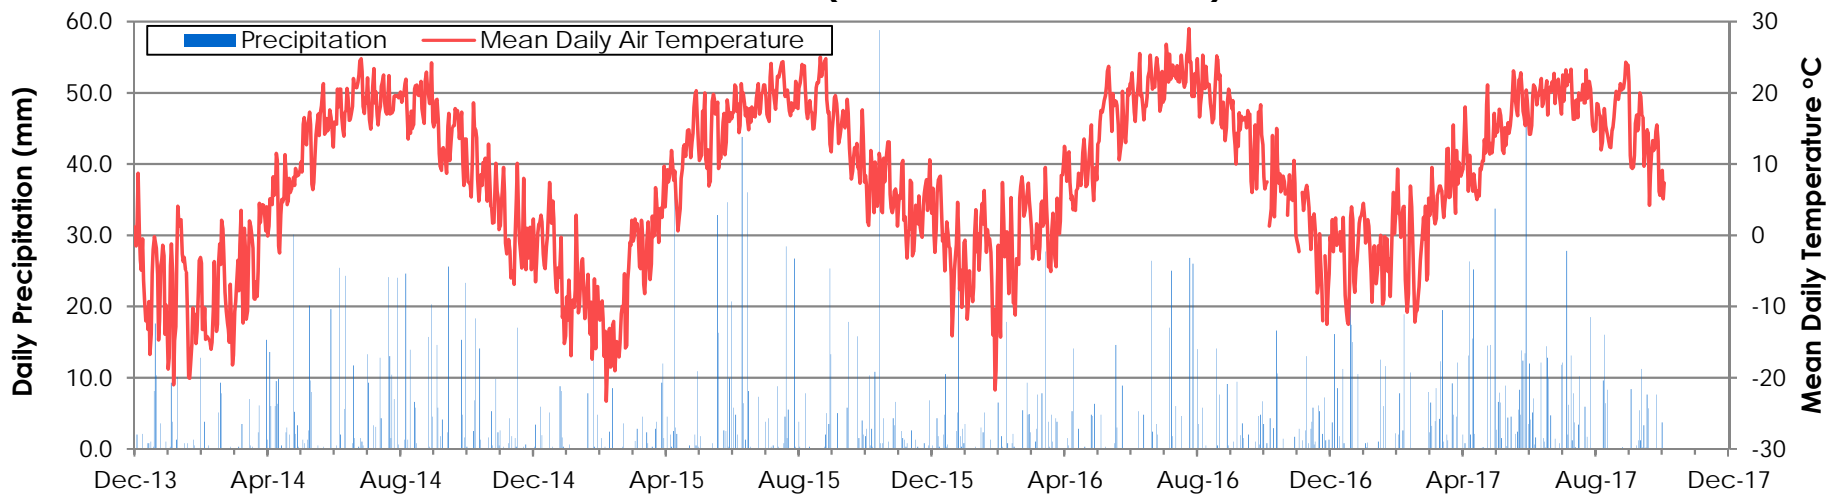
5

Precipitation and temperature data were obtained from Environment Canada for the Oshawa Climate Station. Climate data gaps were filled using data from the Blackstock and Oshawa WPCP Climate Stations, as well as the Oshawa Airport data from the Weather Network website.

**Hydrographs
Monitoring Wells MW1, MW6, and MW7**

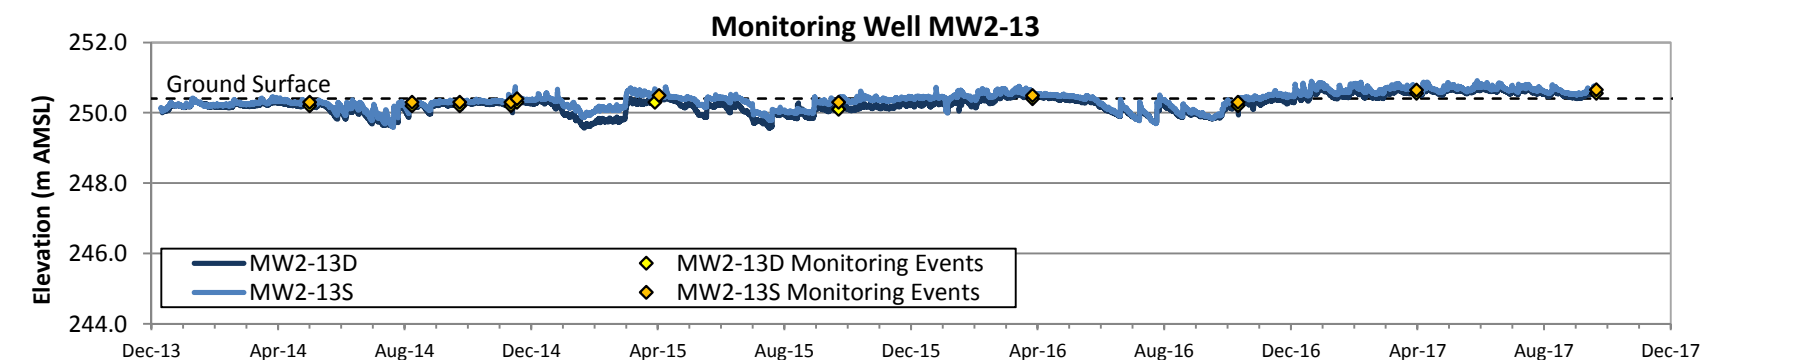
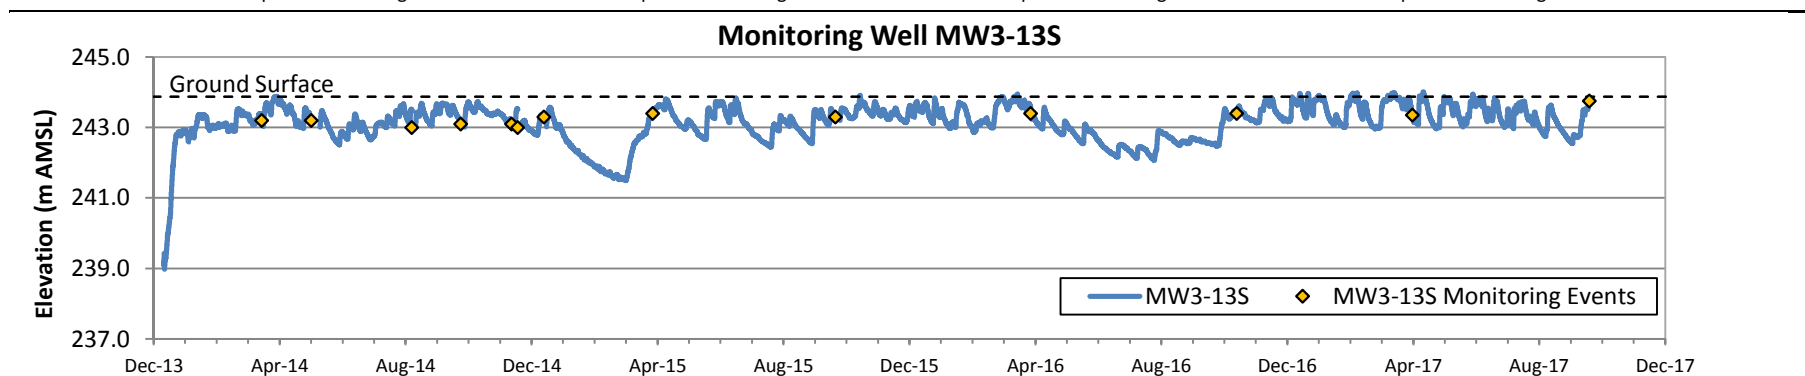
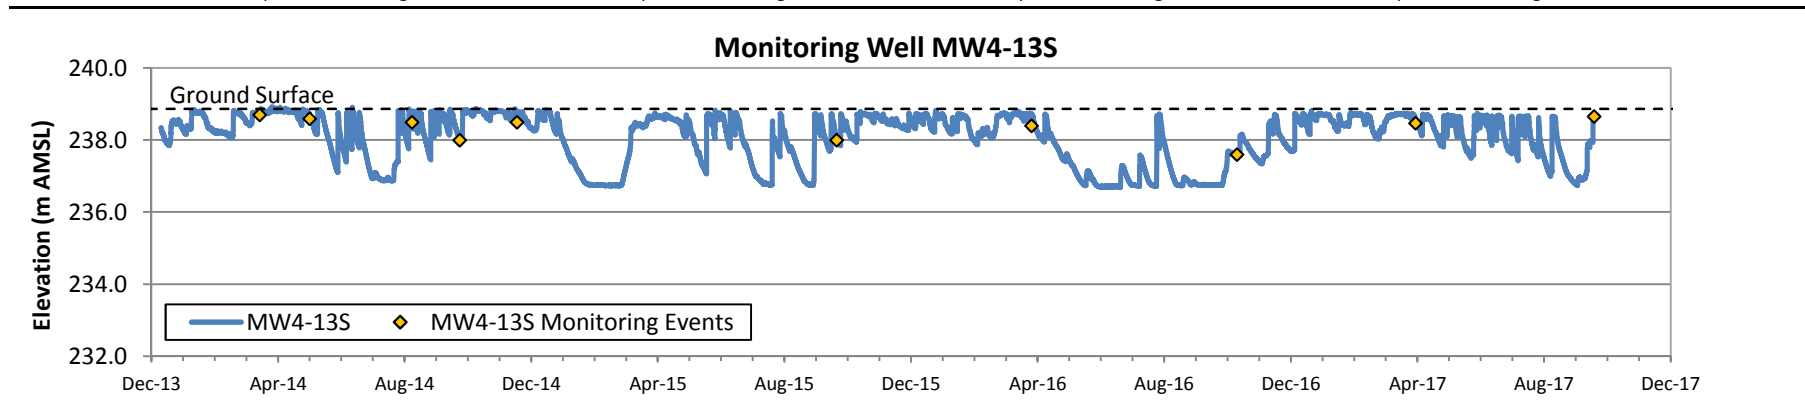
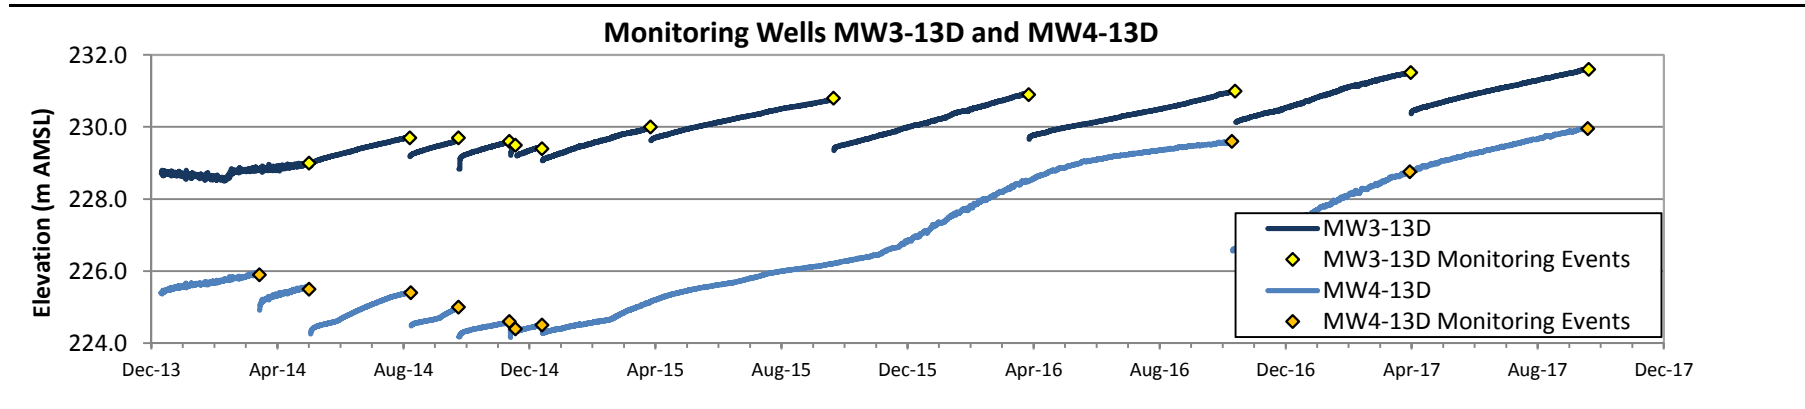
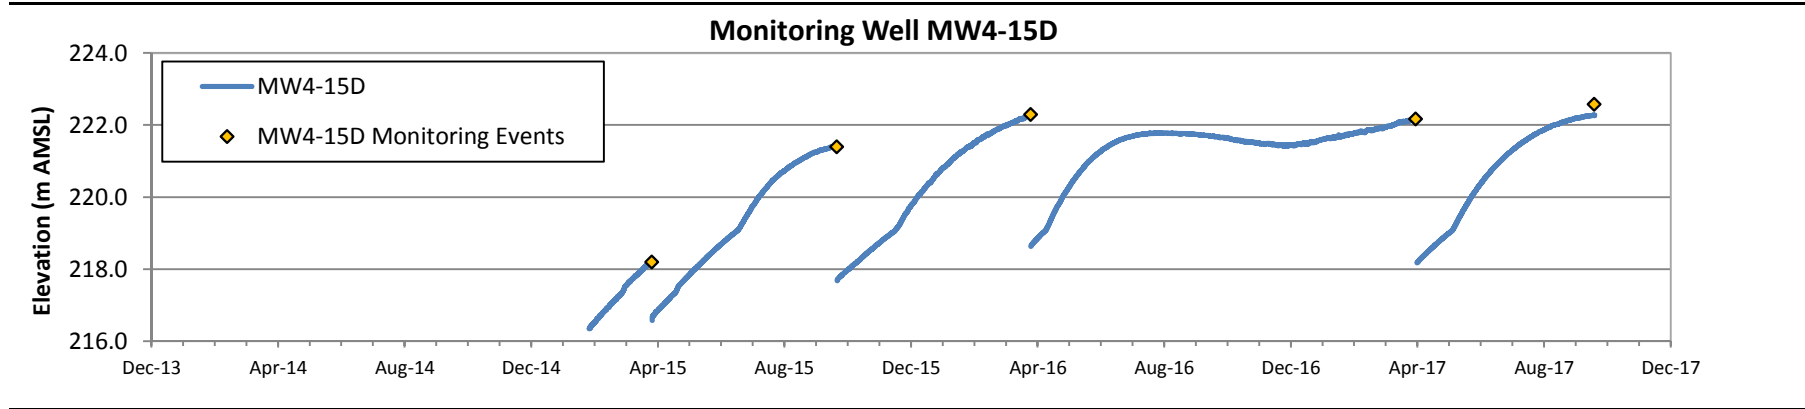
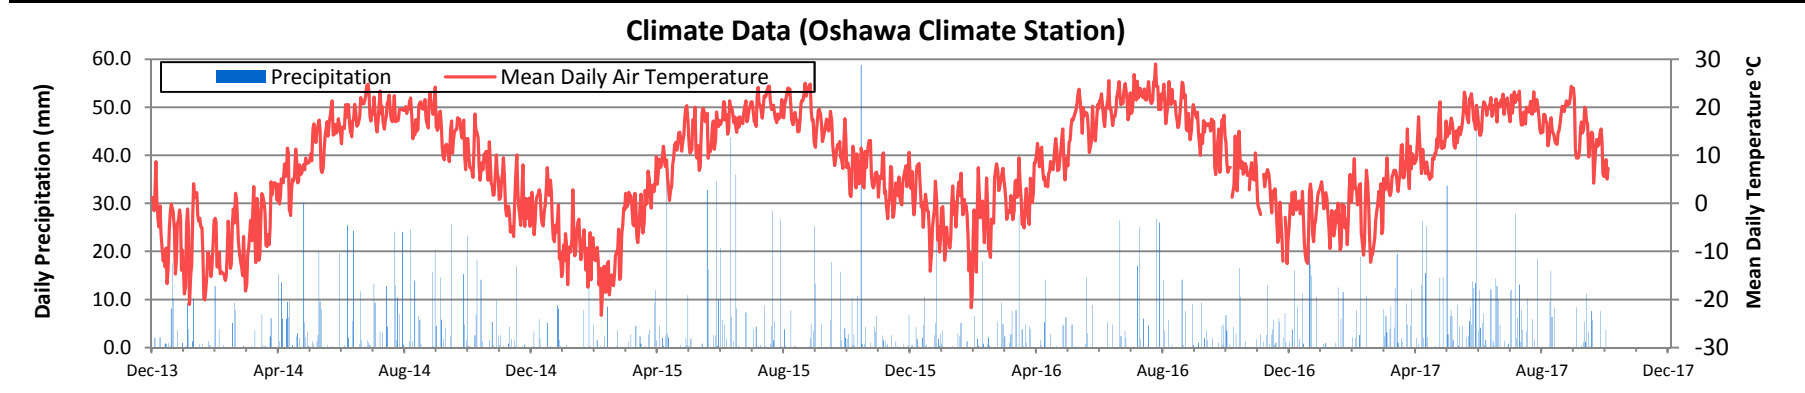
6

Precipitation and temperature data were obtained from Environment Canada for the Oshawa Climate Station. Climate data gaps were filled using data from the Blackstock and Oshawa WPCP Climate Stations, as well as the Oshawa Airport data from the Weather Network website.

Hydrographs
Monitoring Wells MW2, MW3, and MW4

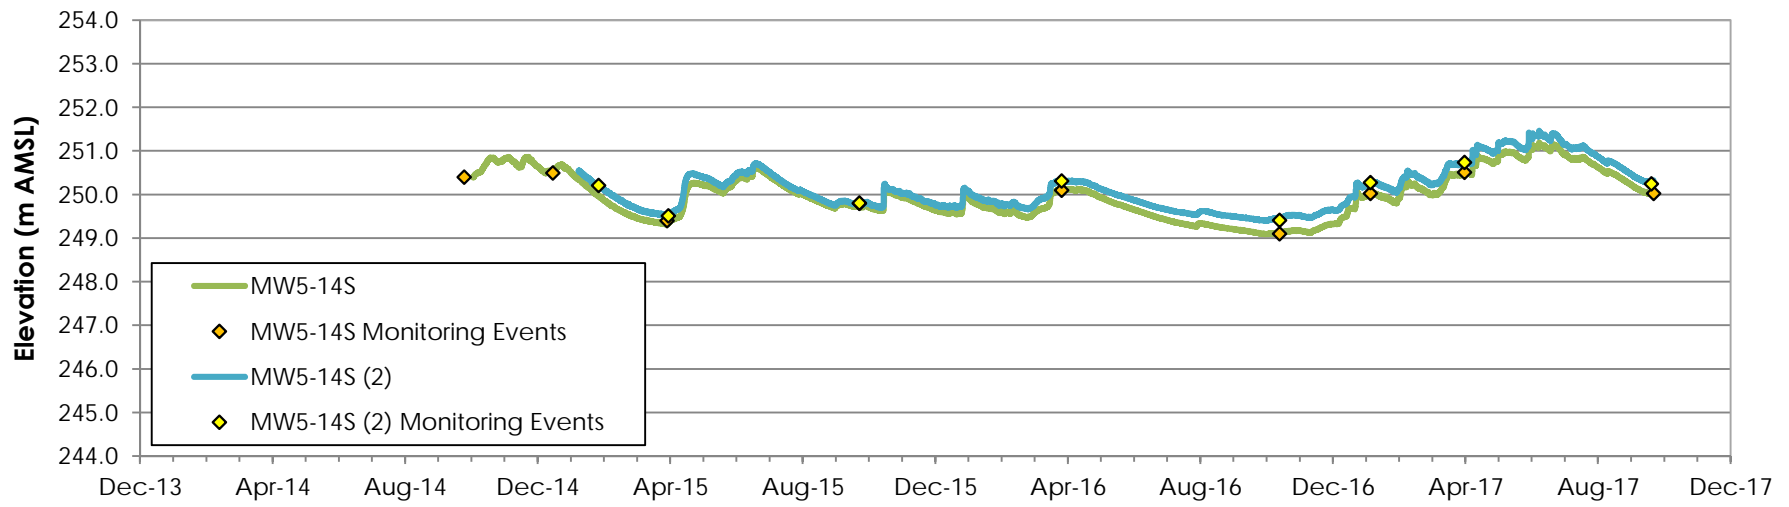
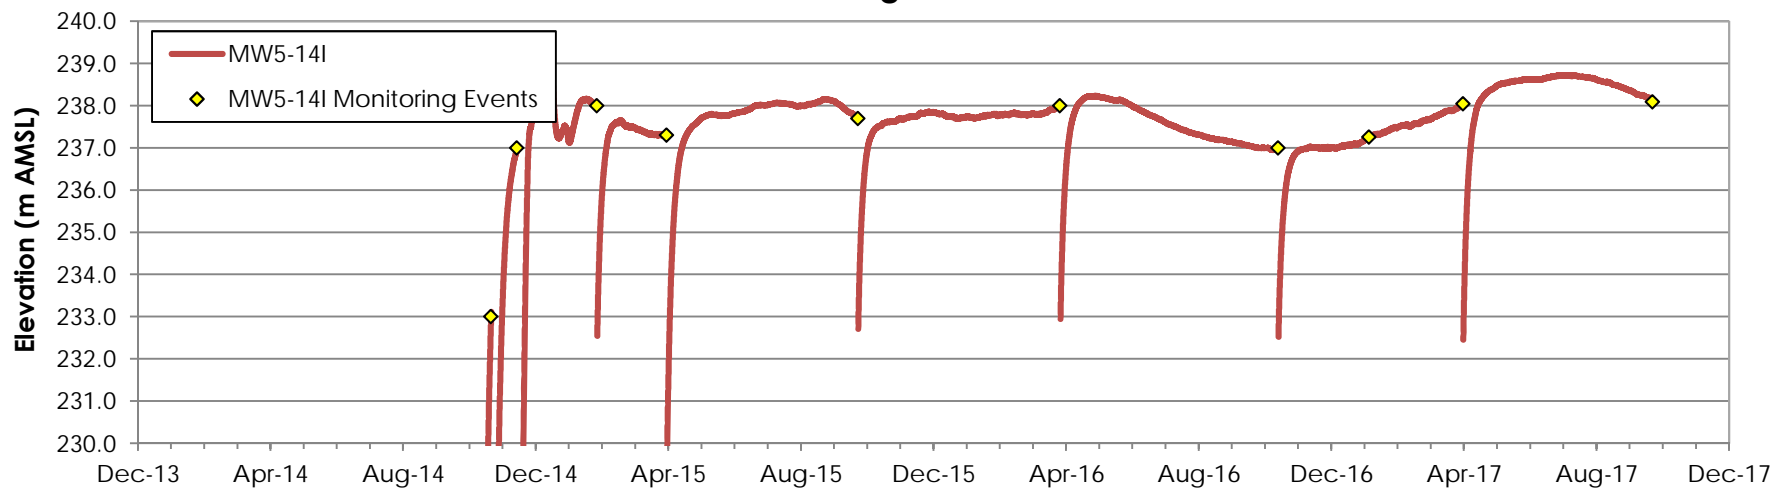
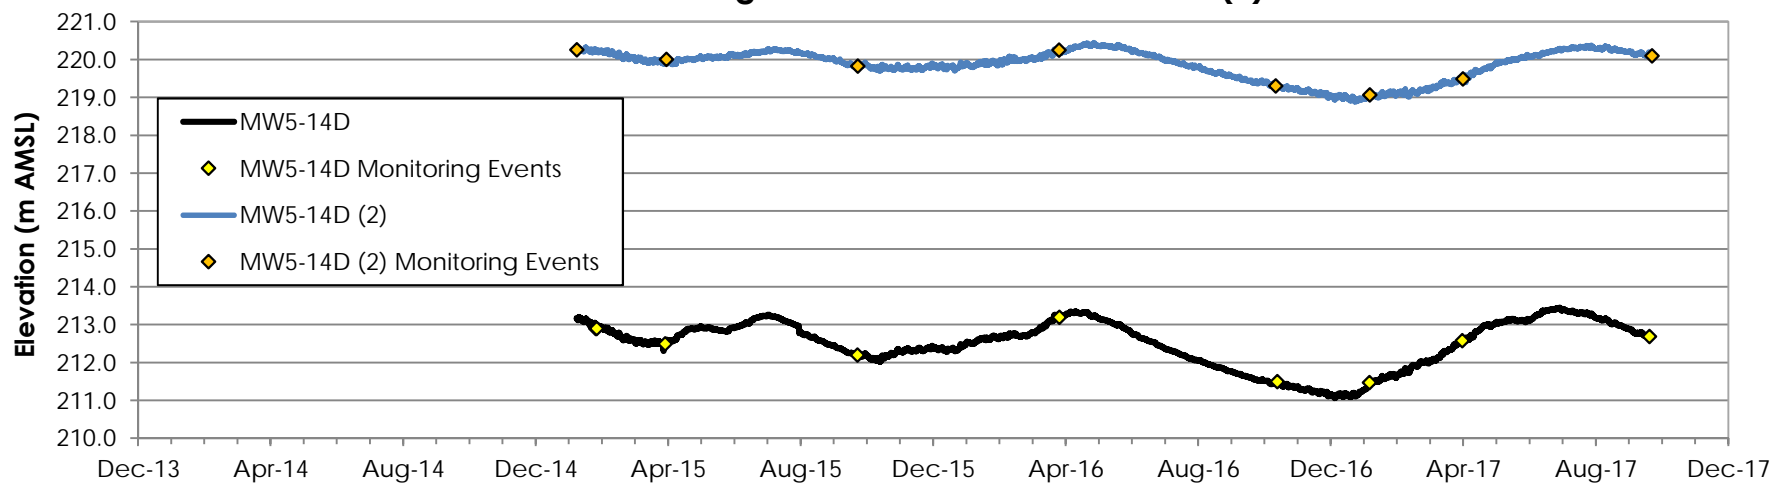
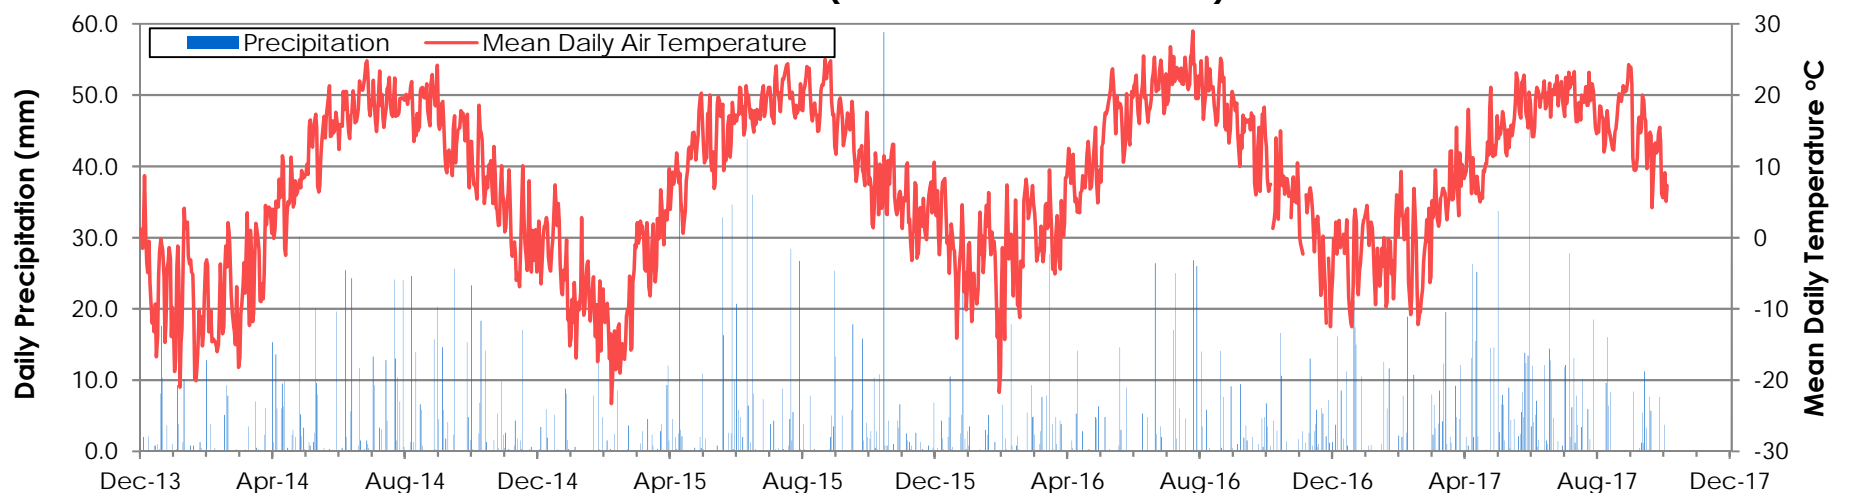
7

Precipitation and temperature data were obtained from Environment Canada for the Oshawa Climate Station. Climate data gaps were filled using data from the Blackstock and Oshawa WPCP Climate Stations, as well as the Oshawa Airport data from the Weather Network website.

**Hydrographs
Monitoring Well MW5**

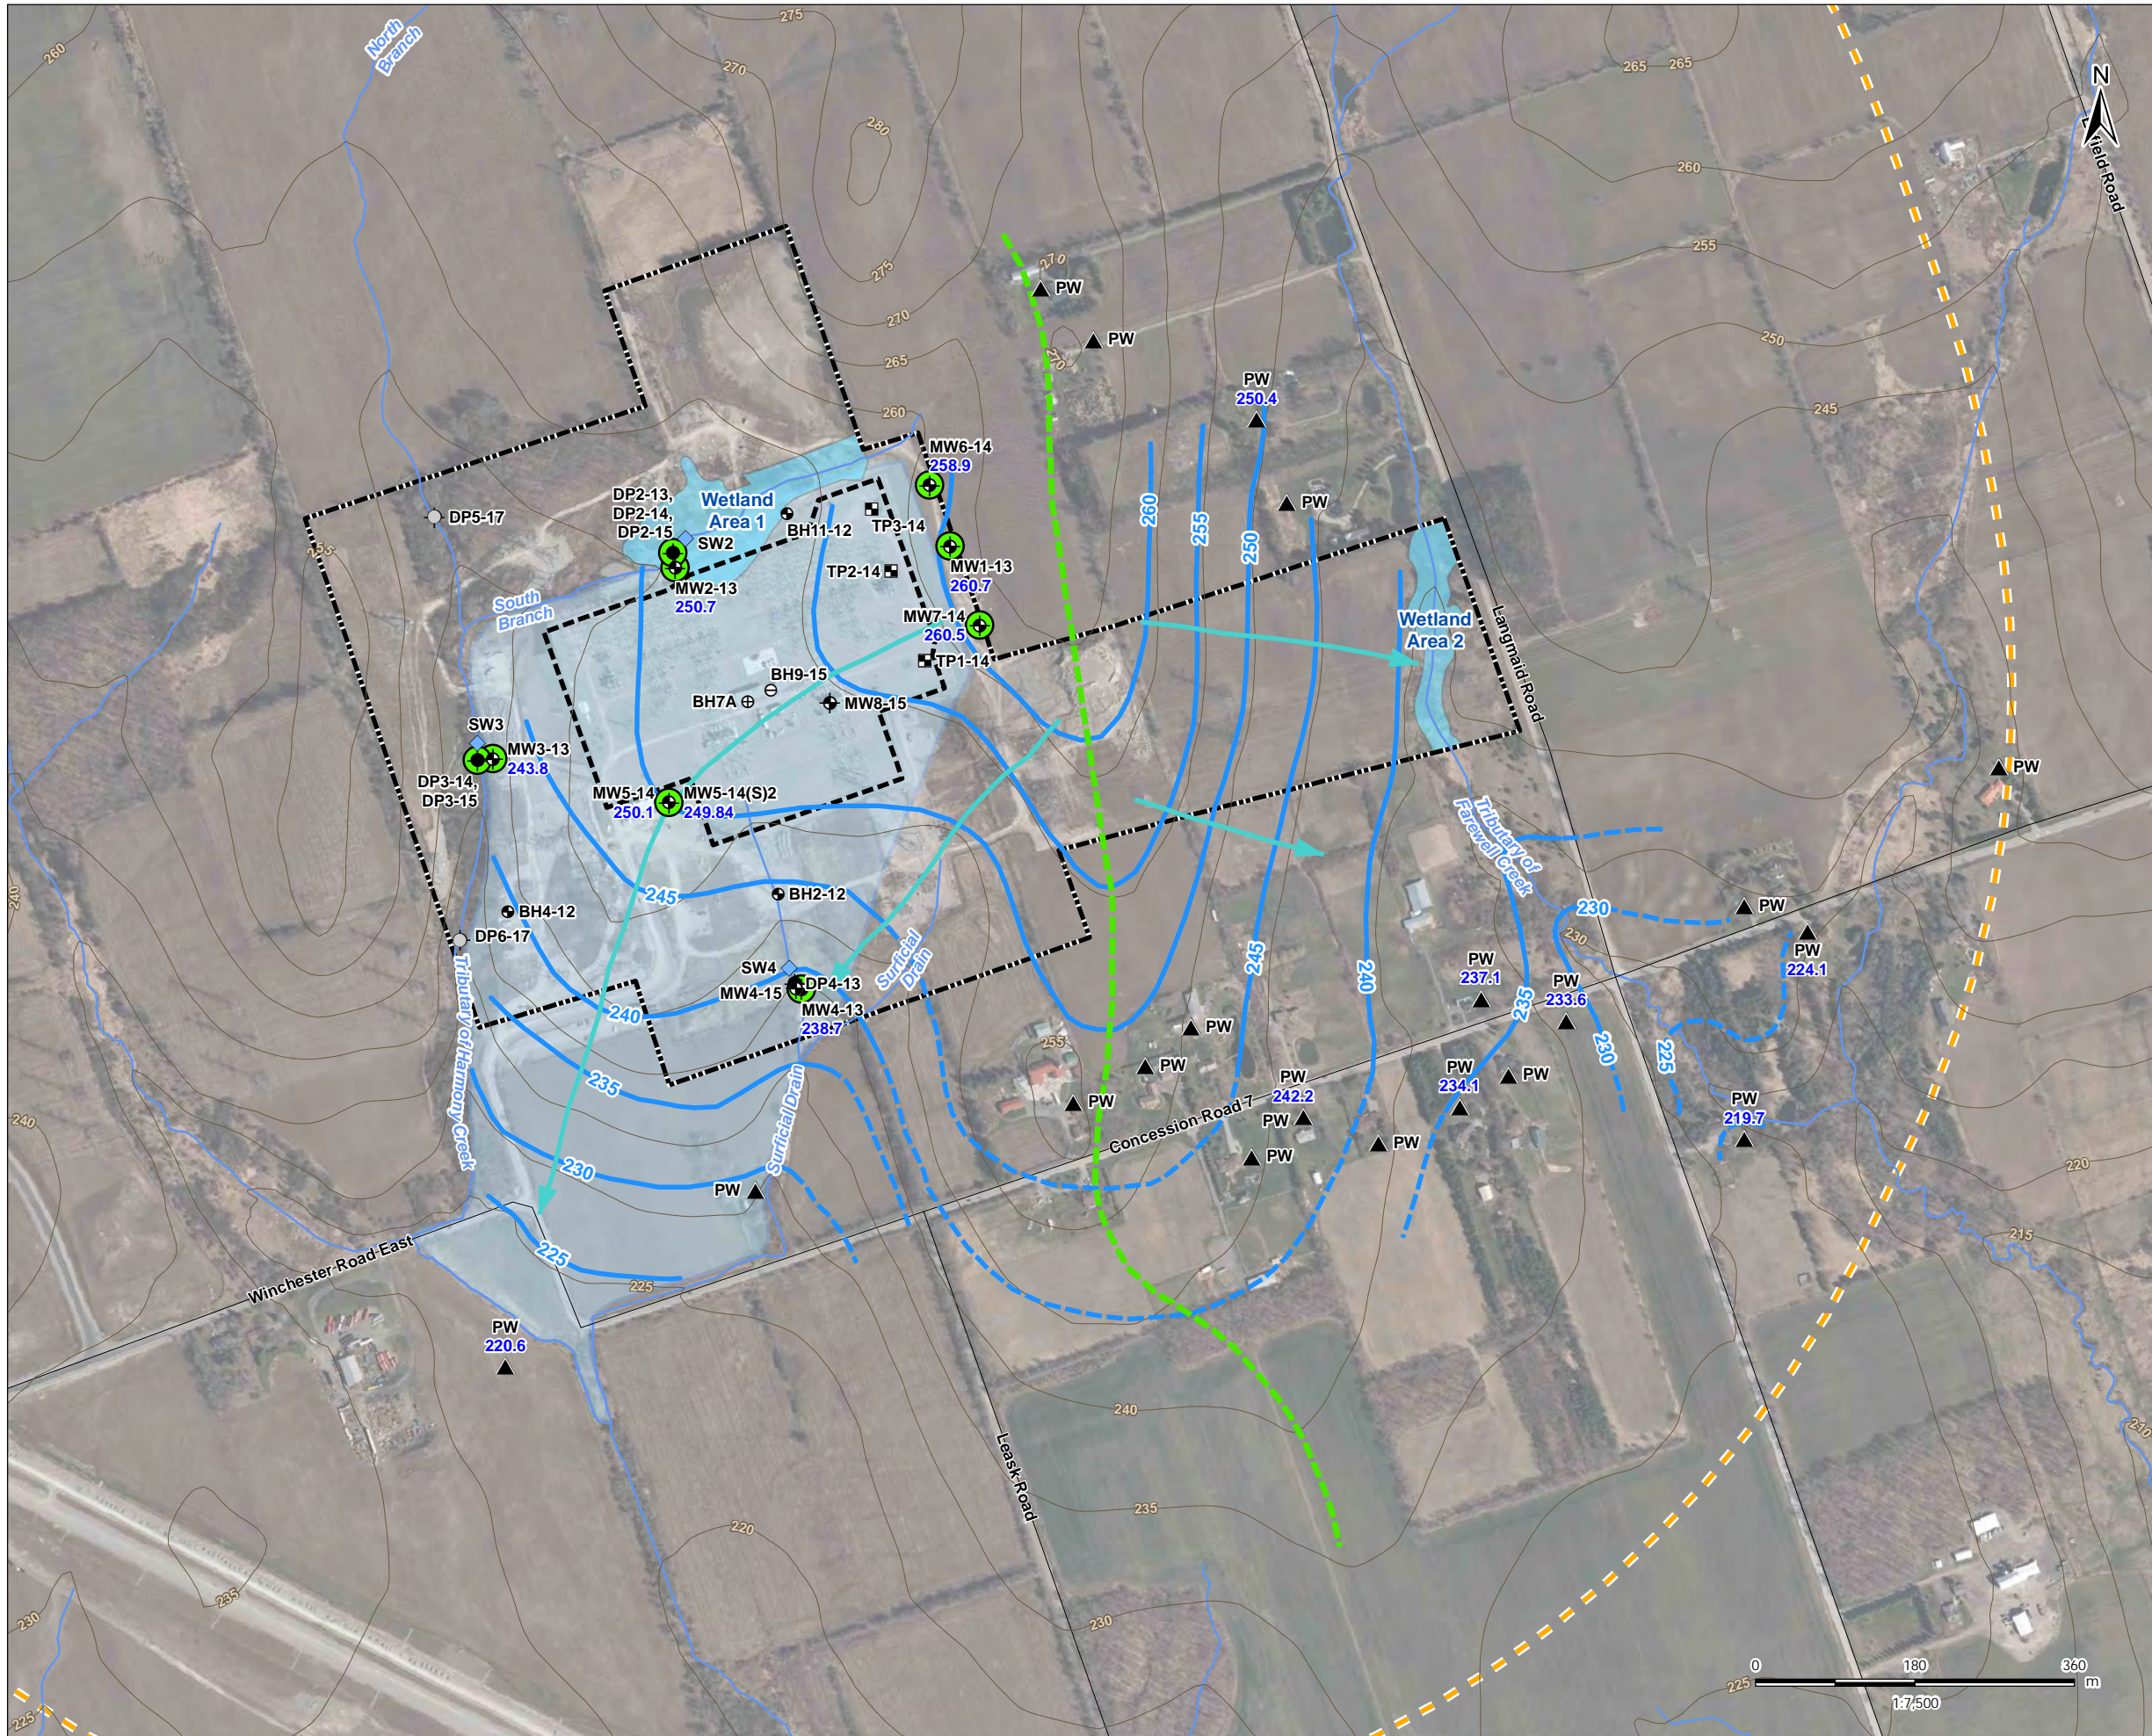
Figure No.
9

- Notes**
1. Coordinate System: NAD 1983 UTM Zone 17N
 2. Base features produced under license with the Ontario Ministry of Natural Resources © Queen's Printer for Ontario, 2013.
 3. Orthoimagery © First Base Solutions, 2017.
 4. Water levels for wells are representative of levels between October 16 and October 18, 2017.

Title
Groundwater Levels Shallow Overburden - October 2017
