APPENDIX A: FIGURES

Client/Project
 2017 Annual Groundwater and
 Surface Water Monitoring Report,
 Hydro One - Clarington
 Transformer Station

Hydro One Networks Inc.
2017 Annual Groundwater and Surface
Water Monitoring Report

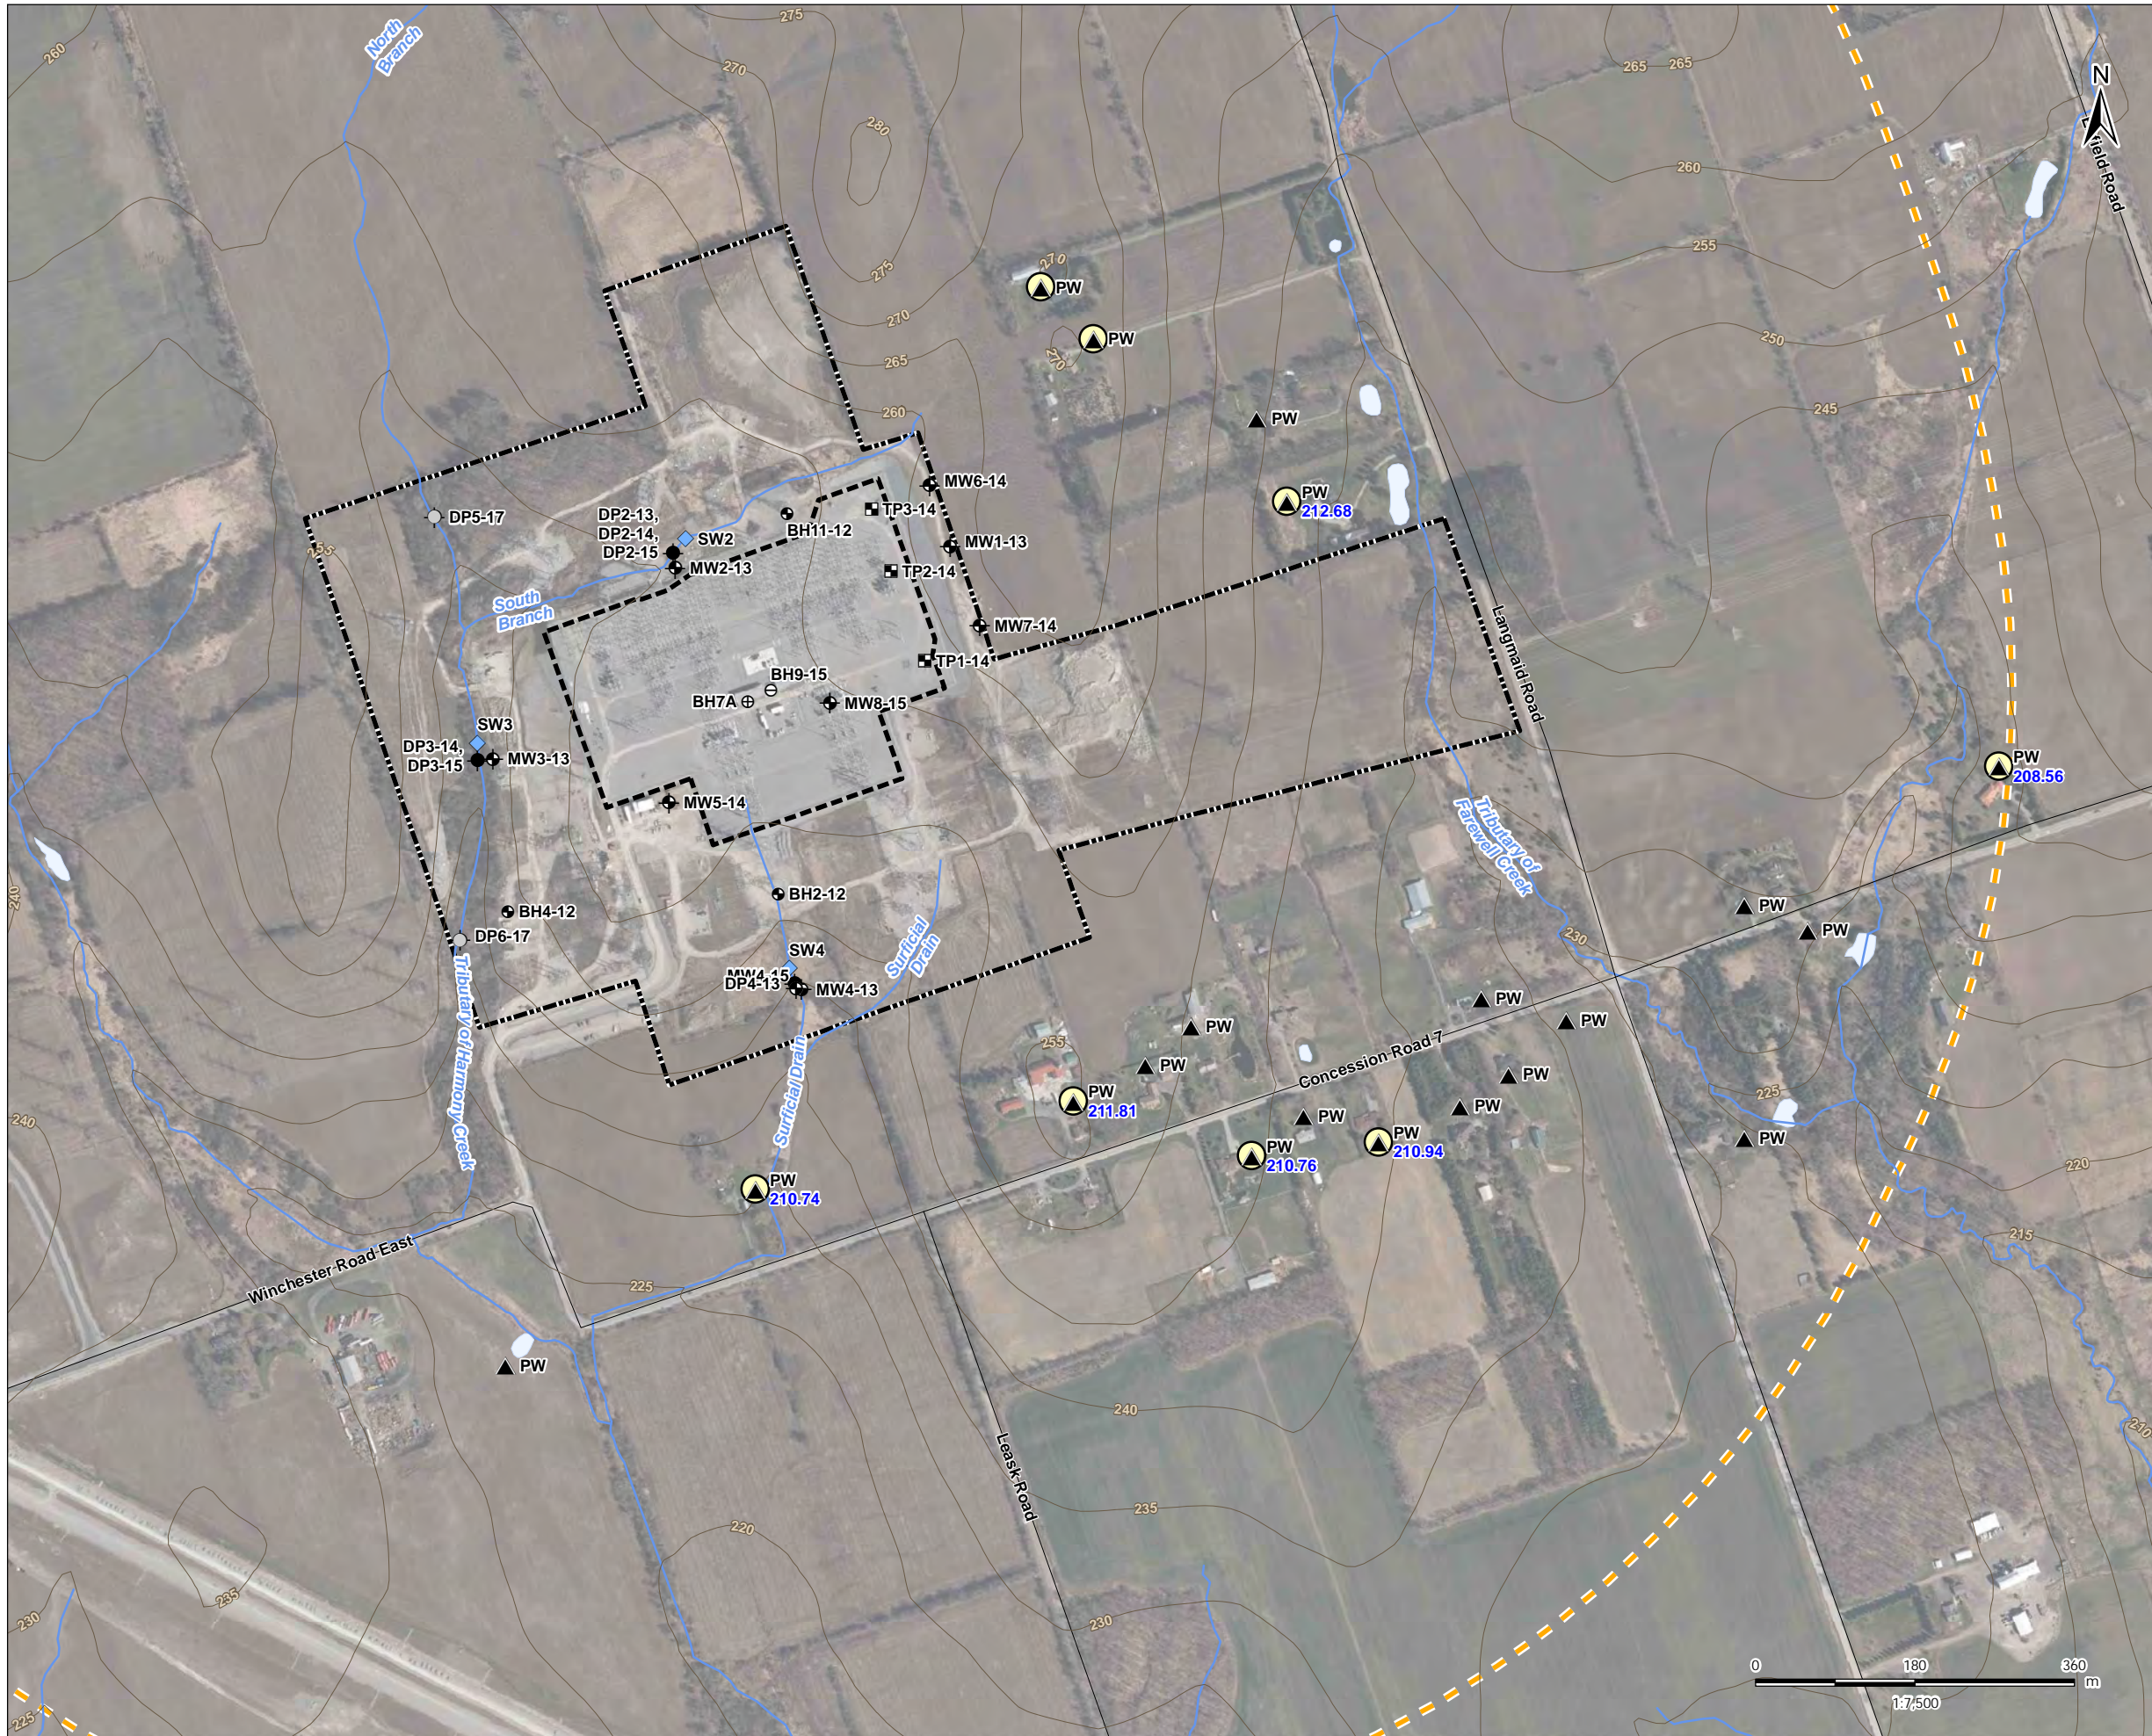
Figure No.
10

- Notes
1. Coordinate System: NAD 1983 UTM Zone 17N
 2. Base features produced under license with the Ontario Ministry of Natural Resources © Queen's Printer for Ontario, 2013.
 3. Orthoimagery © First Base Solutions, 2017.
 4. Water levels for wells are representative of levels between October 16 and October 18, 2017.

Title
Groundwater Elevations
Thorncliffe Formation - October 2017

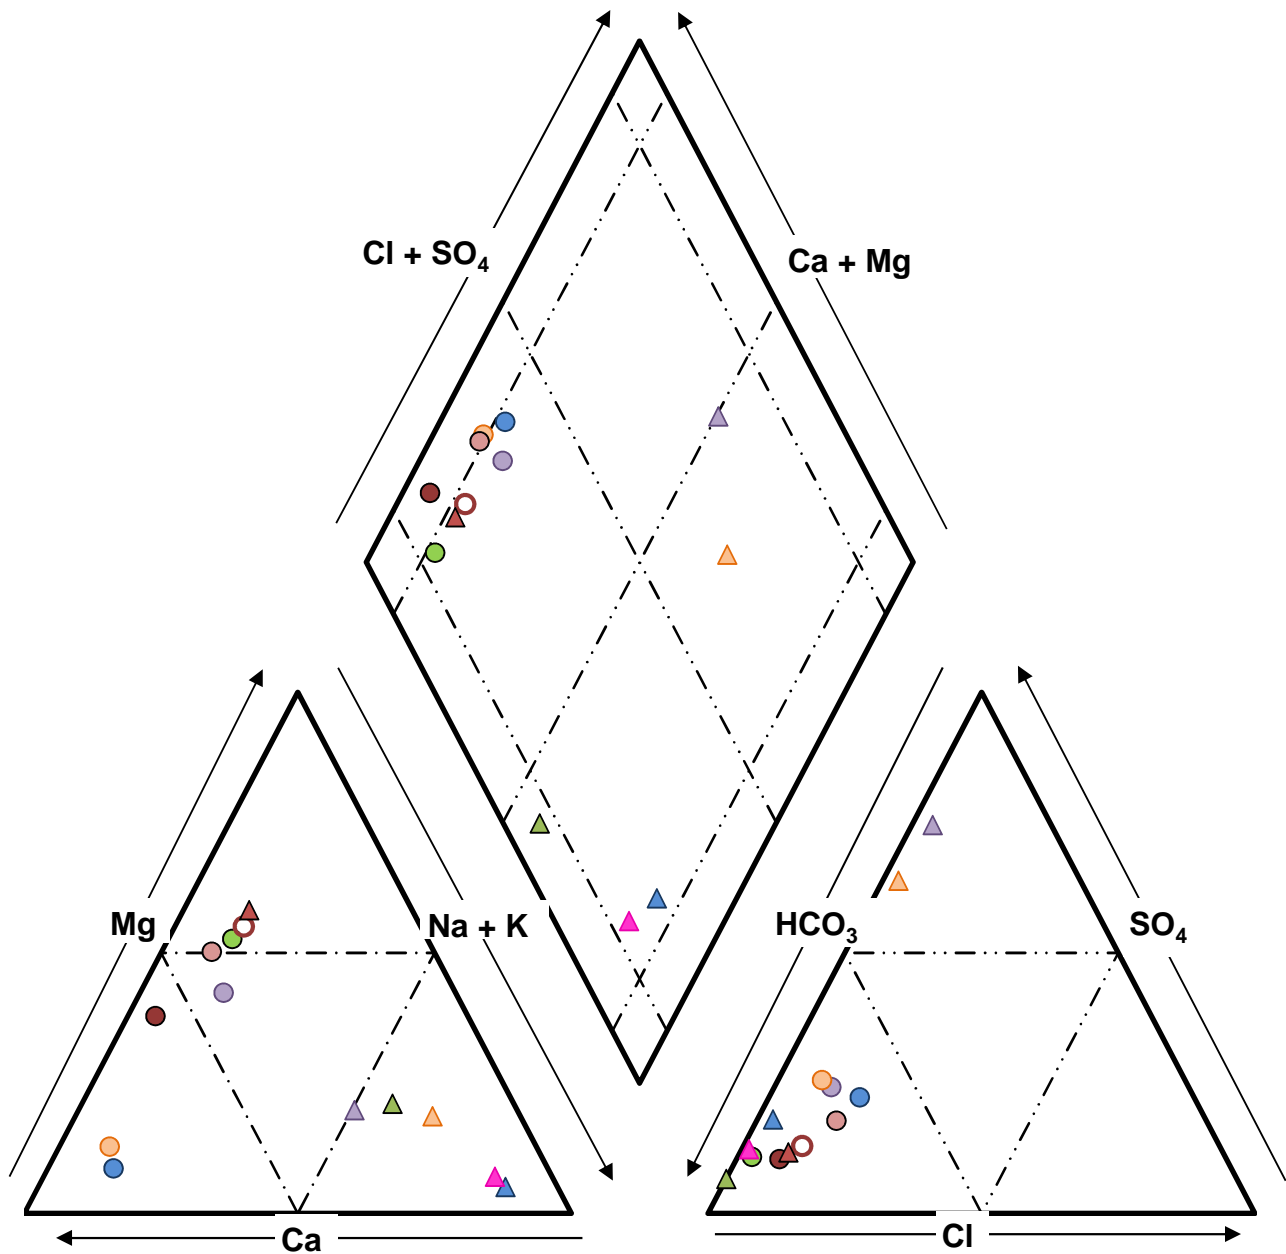
11

Water quality data from groundwater samples were collected on October 16, 2017 at MW4-13S/D, MW5-14S, October 17, 2017 at MW1-13S/D, MW3-13D, MW5-14I, MW7-14, October 18, 2017 at MW2-13S/D, MW3-13S, MW5-14D, October 19, 2017 at MW6-14.

Water Chemistry - Piper Plot
